Slope Stability Analysis Some Selected Sites at Bajalia Anticline in Missan Governorate, Eastern Iraq

Jaffar H.Ali Al-Zubaydi ^{1*}, Ahmed S. Al-Turaihi²

Abstract

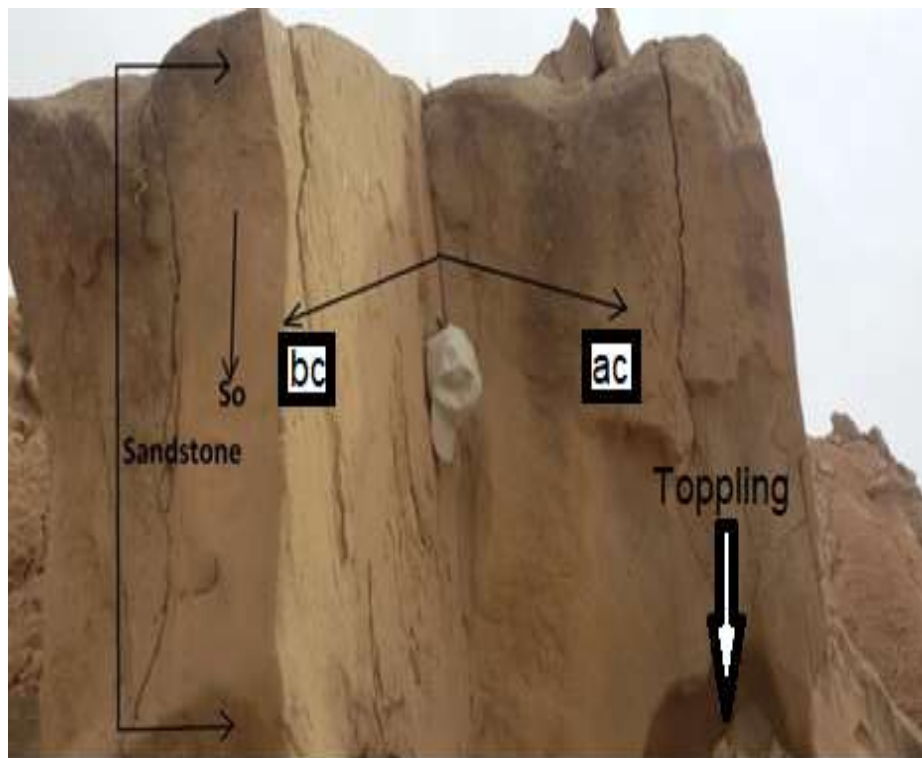
This station may be located at latitude ($32^{\circ} 20' 5''$ N) and longitude ($47^{\circ} 25' 10''$ E) in the Mukdadiya Formation (plate 1). The slope measures 5 meters high and 8 meters long. The slopes at an angle of $290/88$. The average dip layer is ($300/85^{\circ}$). A one-meter-thick layer is exposed at the slope's crest. Light gray, massively bedded, and extensively jointed SANDSTONE Strong ($c = 30$ MPa). The underlying rock strata are 4 m thick at the lower slope. They are SANDSTONE, a light gray, thickly bedded, thick jointed. They have a moderately strong ($c = 20$ MPa).

(ac) and (bc) two sets of discontinuities intersected the layers of sandstone (Figure 3). The spacing of (ac) 1.5–2.0 m extends along the bedding plane to 4 m, (0.15 m) open up. The distance between discontinuities in (bc) is typically between 1 -1.5 m, extending along the bedding plane to 3.5 m, 0.1 m open up. Rock block failure has occurred by rockfall or secondary toppling.

Plate1: Slope and discontinuities of S(1), southwest as the photo's orientation.

1. Removing unstable rock from the slope face, especially stations S1 and S2
2. Applying binders to the slopes lower at the toe, such as cement, rock bolts, and chemical sodium silicates. especially stations S1 and S4
- 3- Use cautionary signs to warn people of potential failure dangers near and on the slopes of the Bajalia anticline for all study stations.

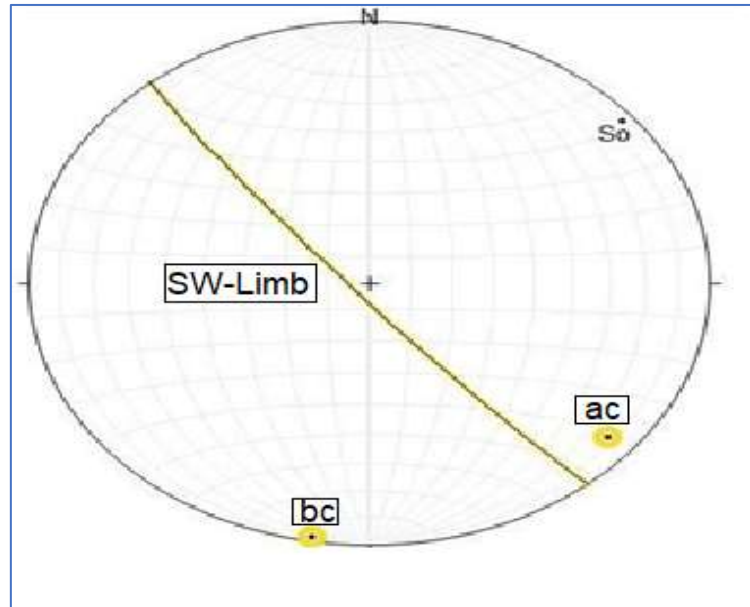
Figure 3: Slope and failure Stereogram of S (1)

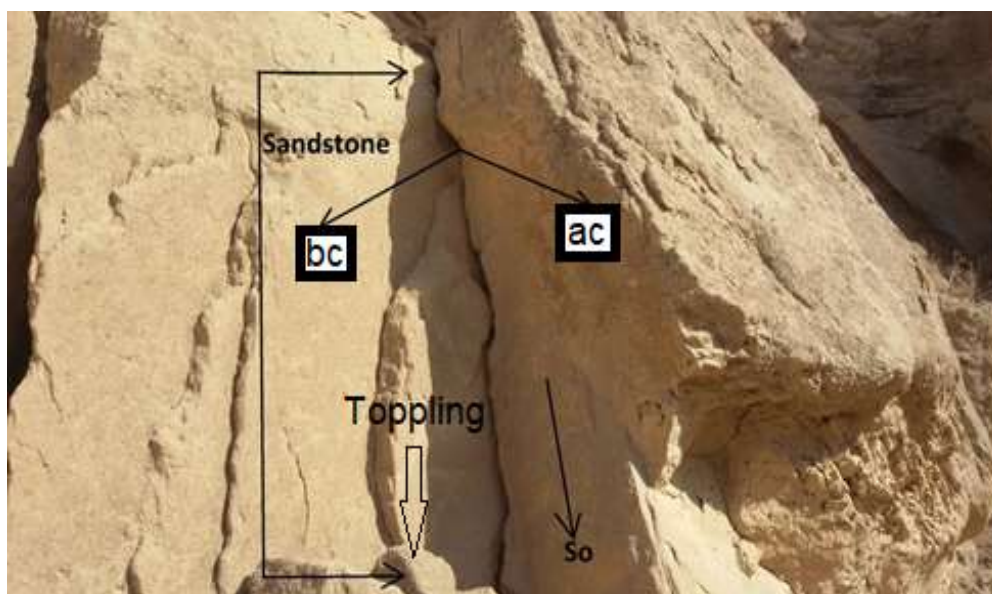
This station may be located in latitude ($32^{\circ} 20' 5''$ N) and longitude ($47^{\circ} 25' 25''$ E) in the Mukdadiya Formation (plate 2). The slope measures 6 meters high and 12 meters long. The slope is at an angle of $320/86$. The average dip layer is ($285/85^{\circ}$). A three-meter-thick layer is exposed at the slope's crest. Pale green, massively bedded, and extensively jointed SANDSTONE Strong ($c = 28$ MPa). The underlying rock strata are 2 m thick at the lower slope. They are SANDSTONE, a light gray, thickly bedded, widely jointed. They have a moderately strong ($c = 26$ MPa), with 1 m thick, pale grayish SILTSTONE ($c = 20$ MPa). Two sets of discontinuities in (ac) and (bc), intersected the layers of sandstone. (Figure 4). The spacing between discontinuities in (ac) is between 0.8 - 1.4 m. They persist up to 3 m along the bedding plane and open up to 0.12 meters. The distance between discontinuities in (bc) is typically between 1 -2.5 m, extending along the bedding plane to 2.8 m, 0.15 m open up. Rock block failure has occurred by rockfall or secondary toppling.

Plate 2: The slope and discontinuities of S(2), photo direction SW

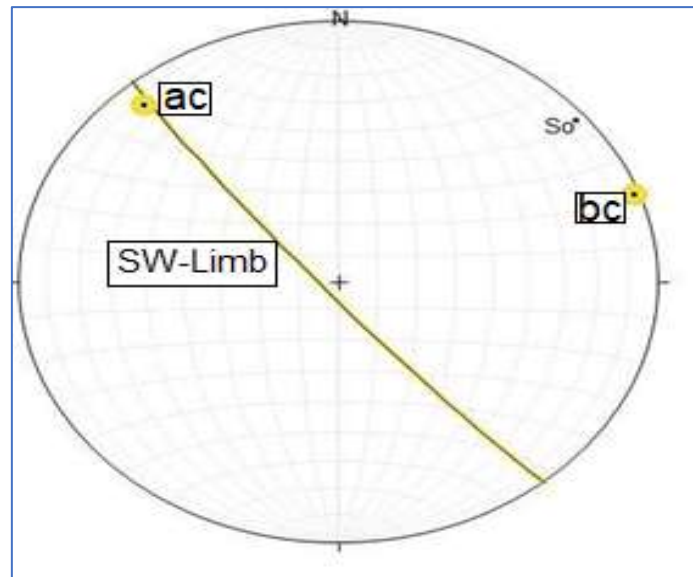
Figure 4: Slope and failure Stereogram of S (2)

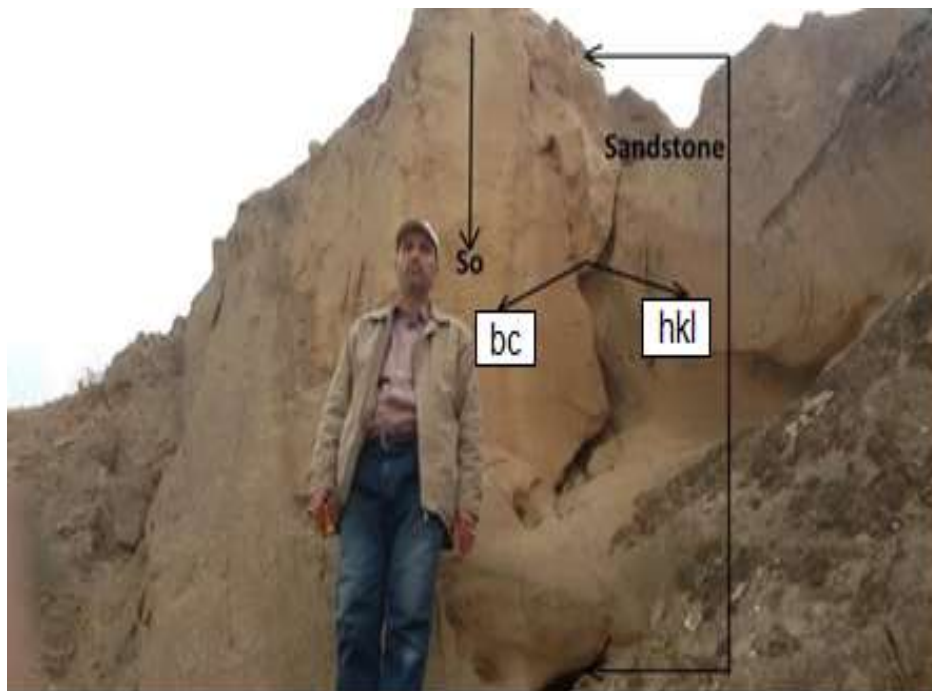
This station may be located at latitude ($32^{\circ} 20' 5''$ N) and longitude ($47^{\circ} 25' 35''$ E) in the Mukdadiya Formation (plate 3). The slope measures 3 m high and 8 m long. The slope is at an angle of $250/88^{\circ}$. The average dip layer is ($285/85^{\circ}$). The one-meter-thick layer is exposed at the slope's crest. Light green, massively bedded, and widely jointed SANDSTONE moderately strong ($c = 26$ MPa). The underlying rock strata are 1 m thick at the lower slope. They are SANDSTONE, a light grayish, thickly bedded, widely jointed. They have a moderately strong ($c = 21$ MPa). Two sets of discontinuities in (hkl) and (bc)), intersected the layers of sandstone. (Figure 5). The spacing between discontinuities in (hkl) is between 1.7-2.3 m. They persist up to 0.6 meters along the bedding plane and open up to 0.17 m. The distance between discontinuities in (bc) is typically between 0.8 -1.3 m, extending along the bedding plane to 1.4 m, 0.01 m open up. The rock mass will fail in the future by rockfall.

Plate 3: The slope and discontinuities of S(3), photo direction SW

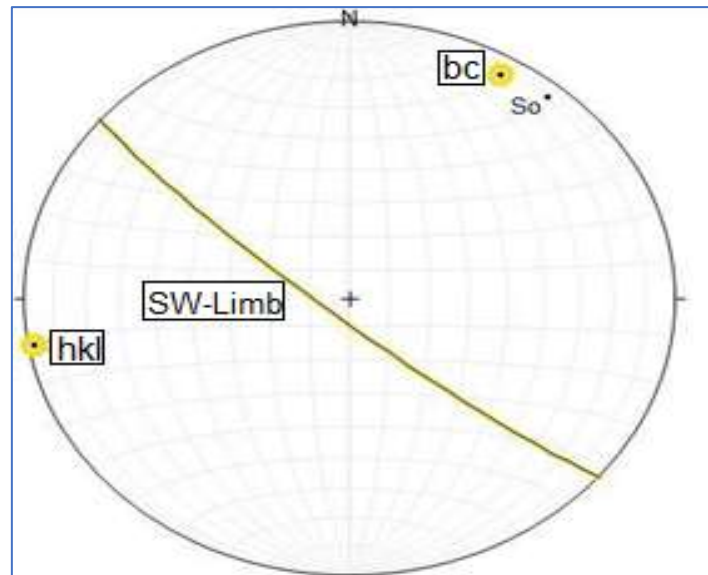
Figure 5: Slope and failure Stereogram of S (3)

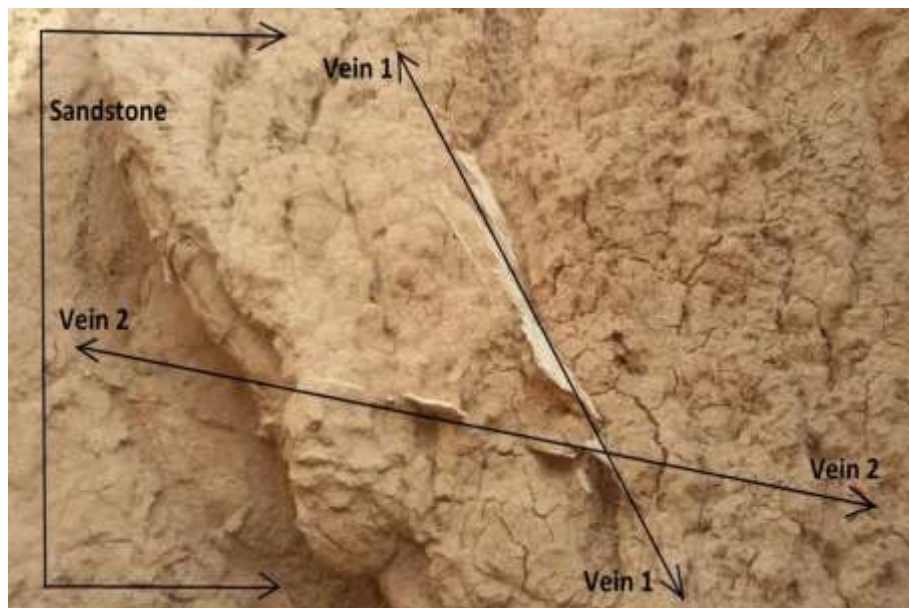
This station may be located at latitude ($32^{\circ} 20' 5''$ N) and longitude ($47^{\circ} 25' 50''$ E) in the Mukdadiya Formation (plate 4). The slope measures 2 meters high and 8 meters long. The slope at an angle of $240/88^{\circ}$. The average dip layer is ($285/85^{\circ}$). The one-meter-thick layer is exposed at the slope's crest. Light green, massively bedded, and widely jointed sandstone moderately strong ($c = 25$ MPa). The underlying rock strata are 1 m thick at the lower of the slope. They are sandstones, a light greyish, thickly bedded, widely jointed. They have a moderately strong ($c = 20$ MPa). Two sets of discontinuities in (bc) and (hol)) intersected as conjugate the layers of sandstone. (Figure 6). The spacing between discontinuities in (bc) is between 1.5 and 2.2 m persisting up to 0.8 meters along the bedding plane, opening up to 0.16 meters. The distance between discontinuities in (hol) is typically between 0.5 -1.0 m, extend along the bedding plane to 1.2 m, 0.01 m open up. The rock mass will fail in future by secondary toppling due to the intersection of (vein1 and vein2).

Plate 4: The slope and discontinuities of S(4), photo direction SW

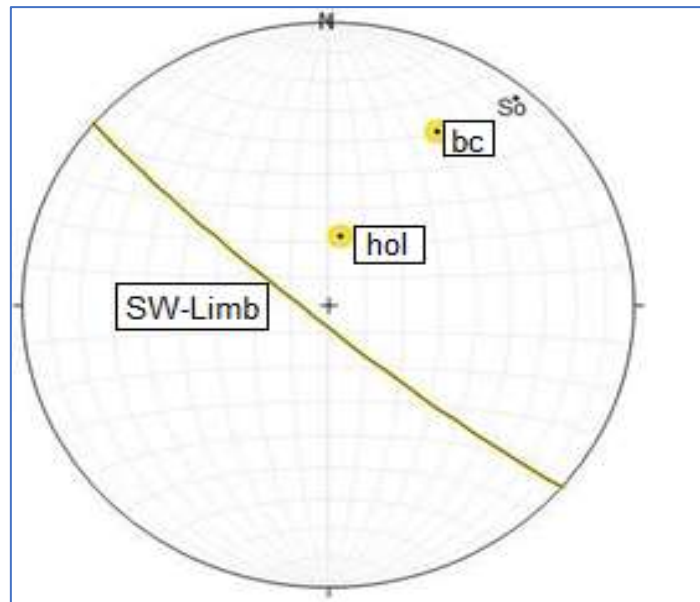
Figure 6: Slope and failure Stereogram of S (4)
