## Impact of Geological Structures on Rock Slope Stability in The NW Nose (Plunge ) of Surdash Anticline, Sulaimaniya/ NE Iraq

For assessing the stability of the rock slopes in the area, 9 stations were selected along the upper Dukan road on both sides of Surdash anticline, and their stability was evaluated by the kinematic analysis using DIPS V6.008 software.

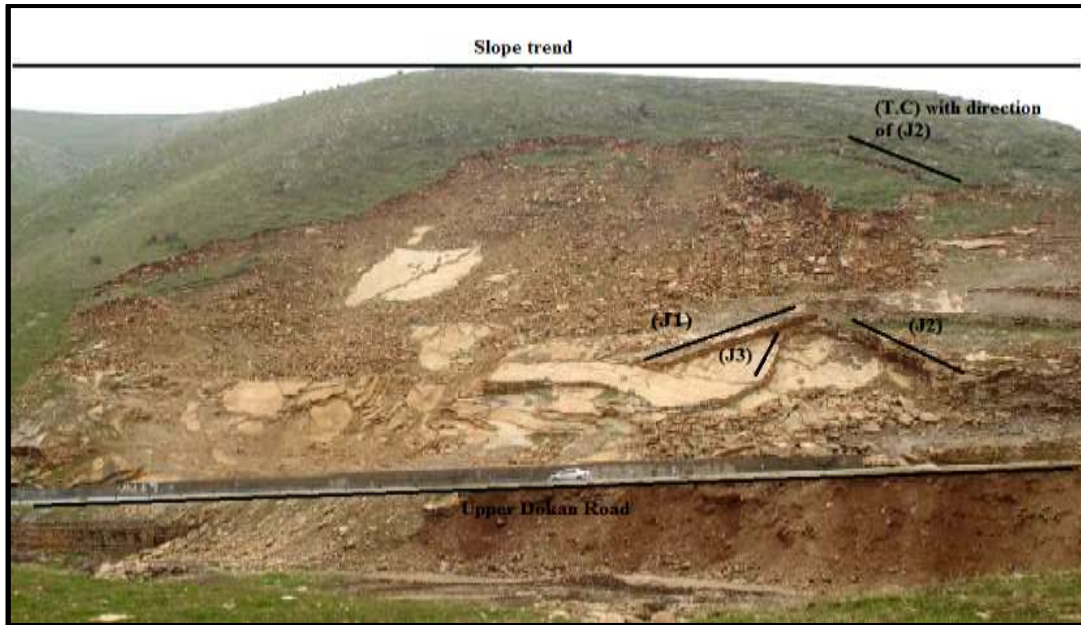
Kinematic analysis revealed that the plane sliding occurred on the bedding plane (So) towards 015°, which in turn acts as basal release surface during sliding (Figure-2a), while J1, J2 and J3 act as lateral release surfaces.

The upper remaining parts of the slope are also unstable due to the presence of tension cracks and opening of joint sets and, thus, they are expected to fail in the future.

In spite of the presence of basal plane (So) and three critical intersections in the critical area of the direct toppling (Figure-2d), direct toppling is not possible to occur because the suitable dimensions of blocks (width and height) for toppling are not existing in reality (Plate 1).

Plate1- General view for station no.1. Photo was taken in the SW-direction.

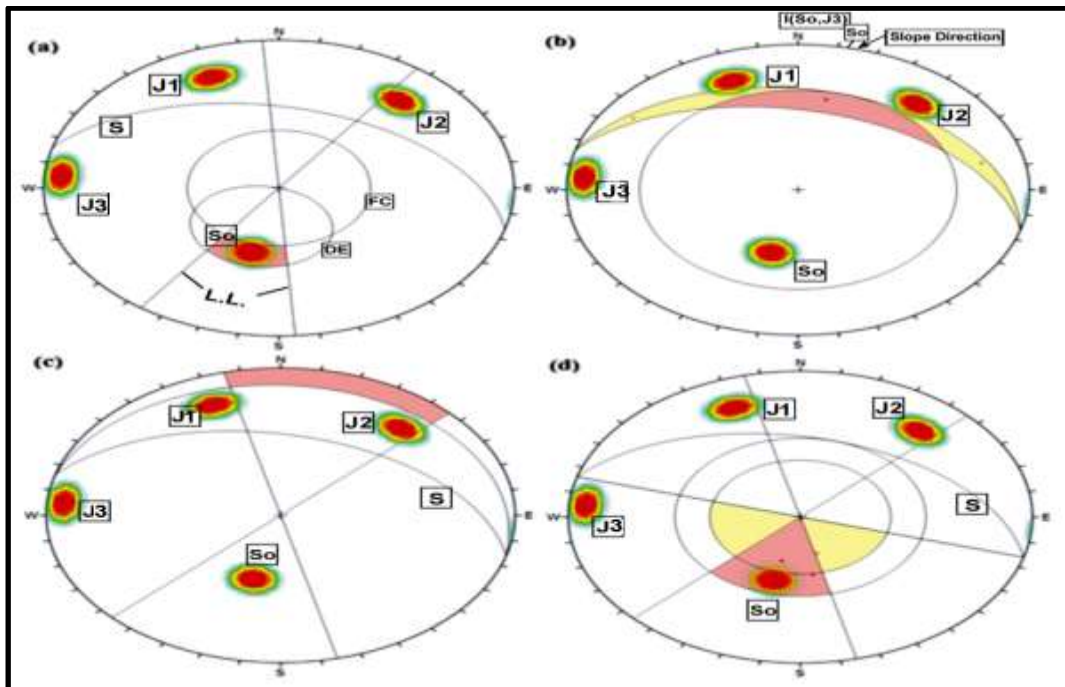
Wedge sliding occurs due to the presence of a pole of the intersection line between So and J3 in the critical area of wedge sliding (pink area), but wedge sliding is not possible because the direction of So is located within the slope direction and plunge direction of the intersection (I (So,J3)), as shown in Figure-2b, this idea was emphasized by [13]&[14].

Flexural toppling was not occurring because no poles were located in the critical area (pink area) defined for flexural toppling (Figure-2c), while no direct toppling occurred.

Figure 2- Kinematic analysis for stationNo.1:(a) plane sliding,(b)wedge sliding,(c)flexural toppling and (d) direct toppling .WhereJ1 is joint set No.1, J2 is joint set no.2, J3 is joint set no.2 is , slope face is(S),bedding plane is (So) ,lateral limits are (L.L), FC is friction cone, DE is daylight envelope and the line of the intersection of the discontinuities is (I).

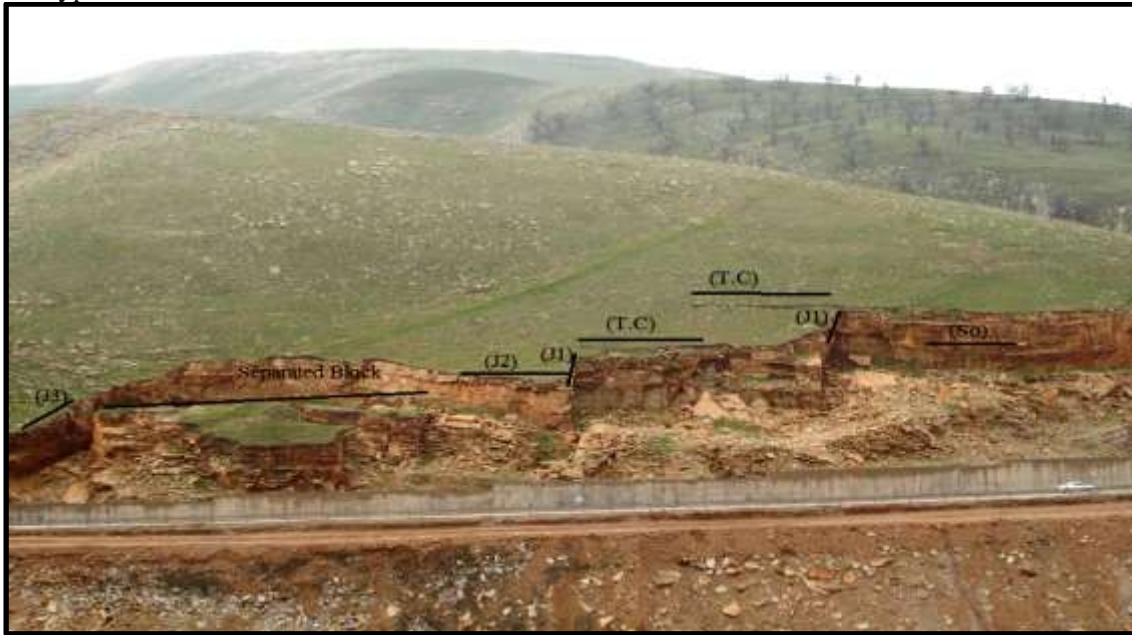
Four discontinuities (a bedding plane and three joint sets) are intersected with the rock mass of this slope, as shown in Figure-3 and plate 2 .From the kinematic analysis , it was clear that plane sliding occurred on the bedding plane (So) towards 020°, which in turn acts as basal release surfaces during sliding, while J1 and J3 act as lateral release surfaces and J2 acts as a back release surface. Occasionally, plane sliding may occur on J2 (J2 and slope face have the same dip direction), as illustrated in Figure-3a. Two tension cracks run parallel to J2 with lengths of about 9m and 20m, extending along J2 and defined rock blocks. These blocks are stable at the present time but they are expected to fail in the future in the form of high angle - plane sliding, according to a previous study. In

**Plate 2-** Front view showing the Bedding plane (So), Joint set No. 1 (J1), Joint set No.2(J2), joint set No.3(J3) and tension cracks (T.C) along J2 in station No. 2. Photo direction is SW.

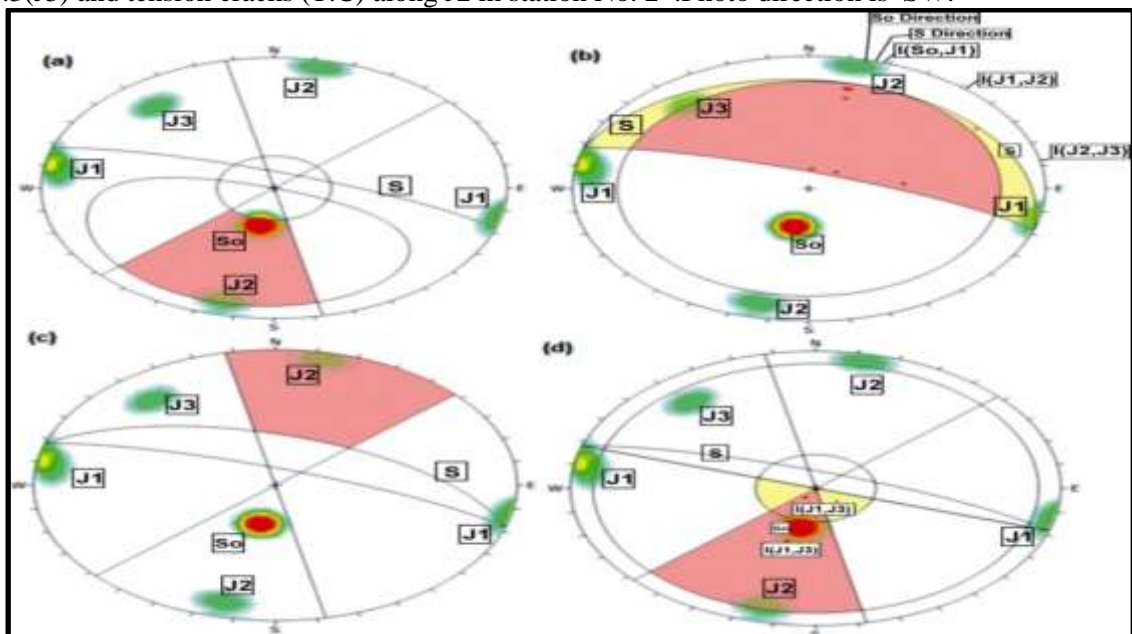
spite of the presence of 6 poles of intersection, the most suitable intersection for the wedge sliding to occur is between J2 and J3 (I(J2 & J3)), as shown in Figure-3b. Figure-3c shows that the pole of J2 (hol<sub>3</sub> type) is located within the area of potential flexural toppling, but it does not occur because the J2 of hol<sub>3</sub> type is alternated by the J2 of hol<sub>4</sub> type which hinders the occurring of flexure toppling. No direct toppling occurs in spite of the presence of two basal planes (So& J2) and three critical intersections in the critical area of direct toppling (Figure 3-d), because the suitable dimension of the blocks (width and height) for the toppling are not existing in the field. In other words, the stereographic projection is not able to identify the block dimension but it only gives the possibility of failure types.

**Figure 3-** Kinematic analysis for station No.2:(a) plane sliding,(b)wedge sliding,(c)flexural toppling and (d) direct toppling. Where J1 is joint set No.1, J2 is joint set no.2, J3 is joint set no.3, slope face is (S), bedding plane is (So) and the line of the intersection of the discontinuities is (I).

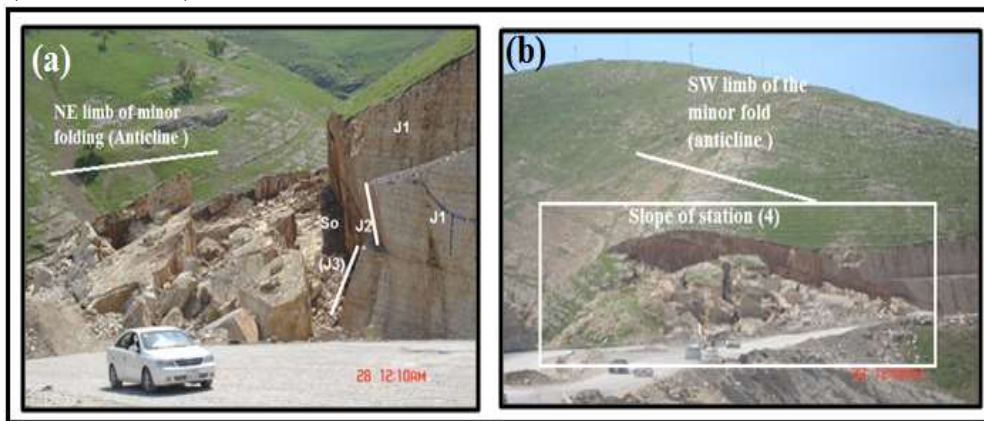
set No.2 (J2) and Joint set No.3 (J3) which is a random joint set that has a spacing of more than 5 m (Plate-3).

The wedge sliding is not occurring, despite the pole of the intersection line between So & J2 which is located in the shaded area (pink color, Figure-4b), because the direction of So is located within the critical zone of the slope direction and the plunge of the intersection line (I (So,J2)). No flexural toppling occurs due to that no poles of any joint sets are located in the shaded area (pink color) of the critical zone of flexural toppling (Figure-4c). Direct toppling is not occurring due to the nonexistence of critical intersections that release blocks in the shaded area with pink color for the critical zone of the direct toppling (Figure-4d). The presence of the slope of station No.4 on the SW limb of the minor fold (anticline) and the road-cut method gave rise to the instability of the slope and induced the landslide (Plate 3a and b).

**Plate 3a-** Bedding plane(S0) , joint sets one (J1), joint set tow (J2) and joint set three (J3). The photo was taken in the direction SW. 3b shows the slope of station No.3 which is located at the SW limb of the minor anticline .

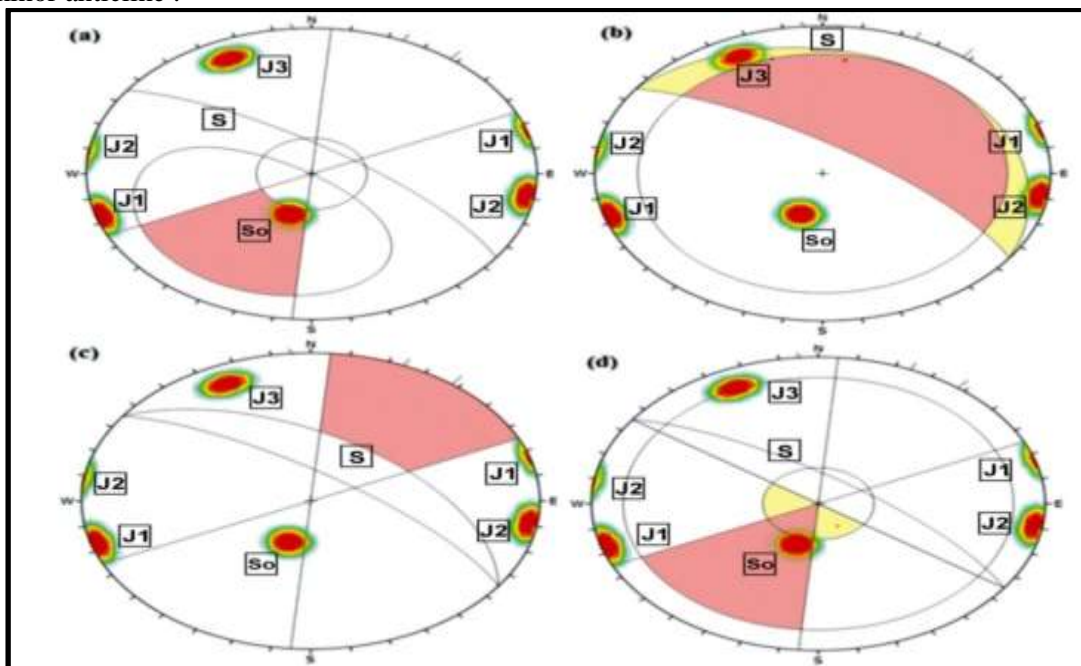
From Figure-4a, it is clear that a planar sliding occurred on the bedding plane (So) due to the presence of bedding plane poles in the potential plane sliding area shaded with pink color and in the direction of 048°. The sliding J1 & J2 act as oblique release surfaces according to a previous study, while J3 acts as a lateral release surface. The presence of a Claystone bed with a thickness of about 4cm, interbedded with limestone beds, played a role in accelerating the planar sliding.

**Figure 4-** Kinematic analysis for station No.3:(a) plane sliding,(b)wedge sliding,(c)flexural toppling and (d) direct toppling .WhereJ1 is joint set No.1, J2 is joint set no.2, J3 is joint set no.2,slope face is (S),bedding plane is (So) and the line of the intersection of the discontinuities is (I).

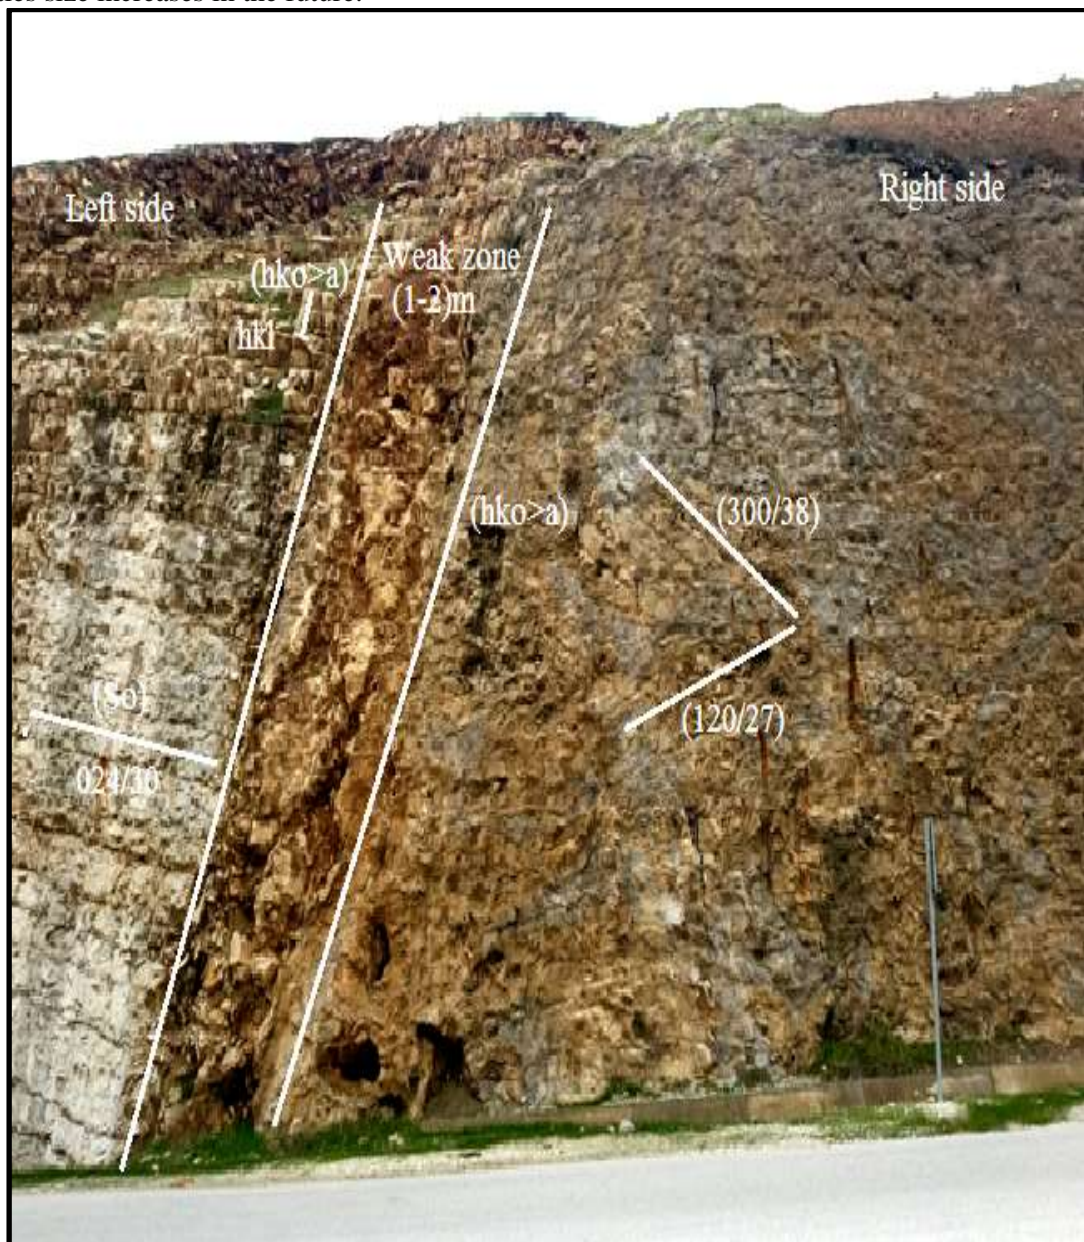
In this station which is shown in plate 4, there is a minor recumbent fold with an average dip of the two limbs  $300/38^\circ$  and  $120/27^\circ$ . Kinematically, the slope of this station was analyzed and revealed that the planar sliding is not occurring on any discontinuities (Figure-5a). The occurrence of wedge sliding has a very low probability in the direction of the plunge of line of intersection between bedding plane (So) and joint set (J1) ( $I(So, J1)$ ) in the critical area of potential wedge sliding (pink area) (Figure -5b), because the plunge direction ( $323^\circ$ ) of the intersection line is very far from the free face of slope direction ( $28^\circ$ ). No flexural toppling was observed because no poles are located in the critical area of flexure toppling (purple area) (Figure-5c). The direct toppling will not occur in spite of the presence of many critical intersections in the critical area of direct toppling (Figure-5d, due to presence of basal planes of bedding plane (So) in the slope direction and due to unsuitable dimension of blocks (width and height) for toppling in the field. The presence of a recumbent fold in the slope of this station increased the stability of the slope, inspite of the presence of the cavities that resulted from the dissolution of Limestone rock by fluids (rainfall) which in turn may cause slope failure if the cavities size increases in the future.

**Plate 4**-Frontal view showing the slope of station No.4 with Joint sets No.1(J1), No.2(J2) and bedding planes of minor fold (recumbent), which is located at the SW limb of the minor anticline.

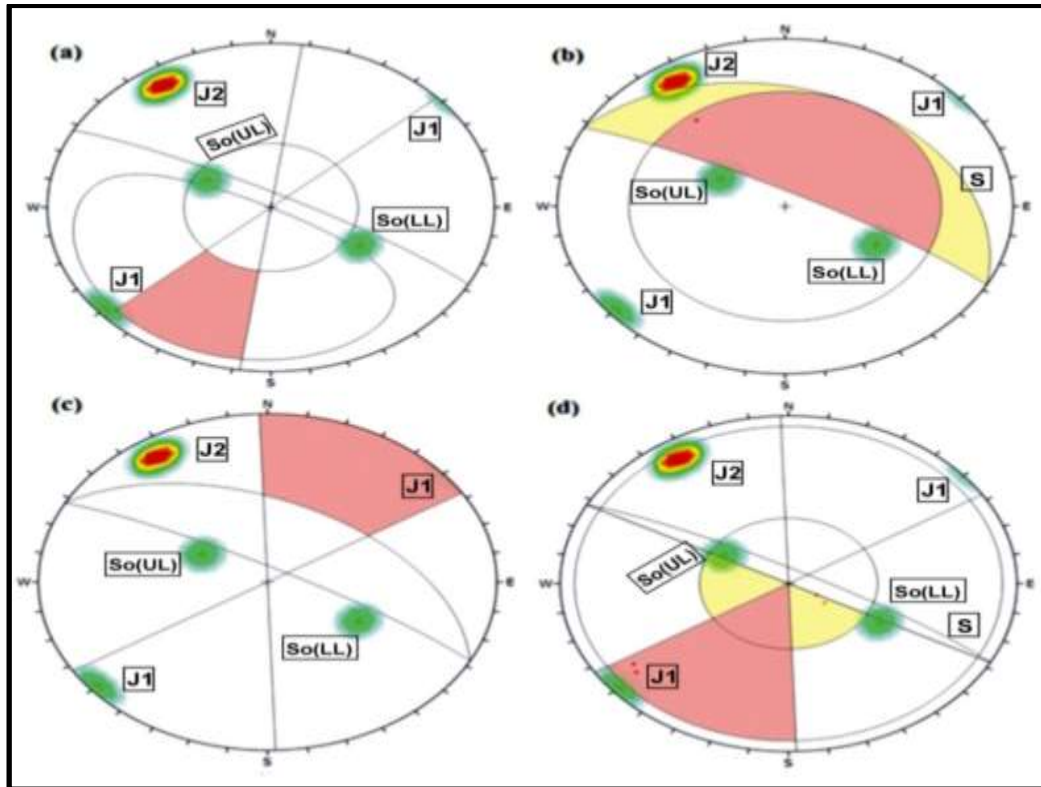
**Figure 5-** Kinematic analysis for station No.4:(a) plane sliding,(b)wedge sliding,(c)flexural toppling and (d) direct toppling .Where J1 is joint set No.1, J2 is joint set no.2,slope face is (S),bedding plane is (So) , the line of the intersection of the discontinuities is (I) ,Upper limb of minor fold (UL) and lower limb of the minor fold(LL).

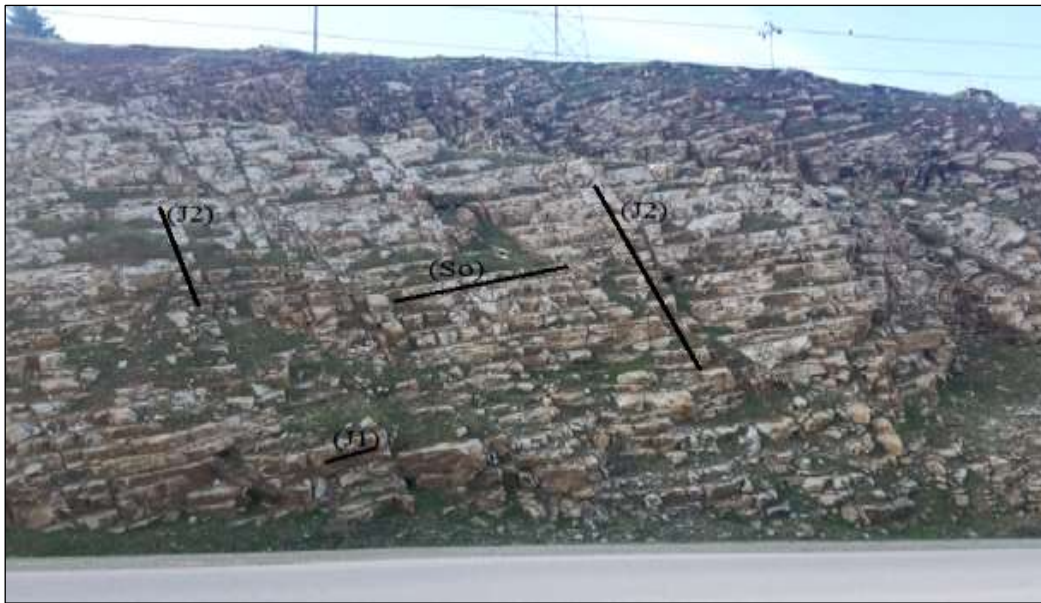
Tow discontinuities cut the rock mass of this slope (Joint set No.1 (J1) and Joint set No.2 (J2) ), in addition to the bedding plane (So) (Plate 5).The planar sliding is not taking place at this slope because the pole of So is out of the shaded area (shaded with pink) which represents the critical zone for the planar sliding (Figure-6a). Wedge sliding is not occurring because there are no intersection line poles between joint sets in the shaded area (colored with pink, Figure -6b). No Flexural toppling is found due to the absence of poles of joint sets in the shaded area (pink color) for the critical zone of flexural toppling (Figure-6c). Figure-6d shows the occurrence of a direct toppling due to the presence of basal plane (So) and pole of intersection line between J1 and J2, but in reality it does not occur because the required height for direct toppling is not available in the field, where in this case the height reflects the bedding thickness. Hence, the slope of this station is stable, except for the presence of rock fall from the upper parts of the slope .

**Plate 5**-Frontal view showing the slope of station No.5 with Joint sets No.1(J1), No.2(J2) and bedding planes (So). Photo direction is SW.

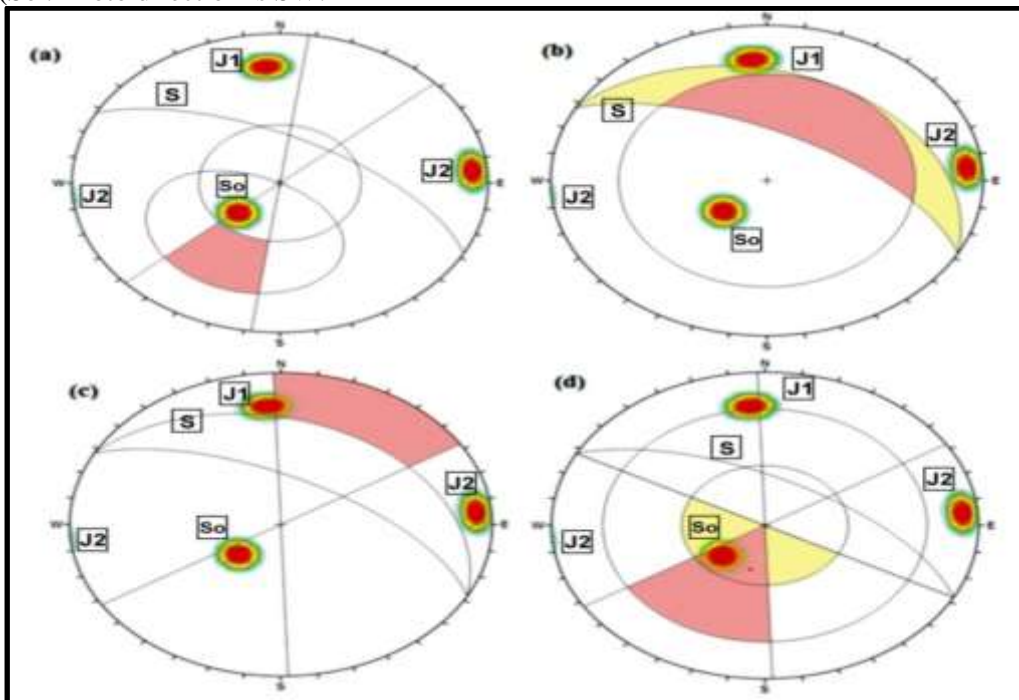
**Figure 6** - Kinematic analysis for station No.5:(a) plane sliding,(b)wedge sliding,(c)flexural toppling and (d) direct toppling .Where J1 is joint set No.1, J2 is joint set no.2,slope face is (S),bedding plane is (So) .

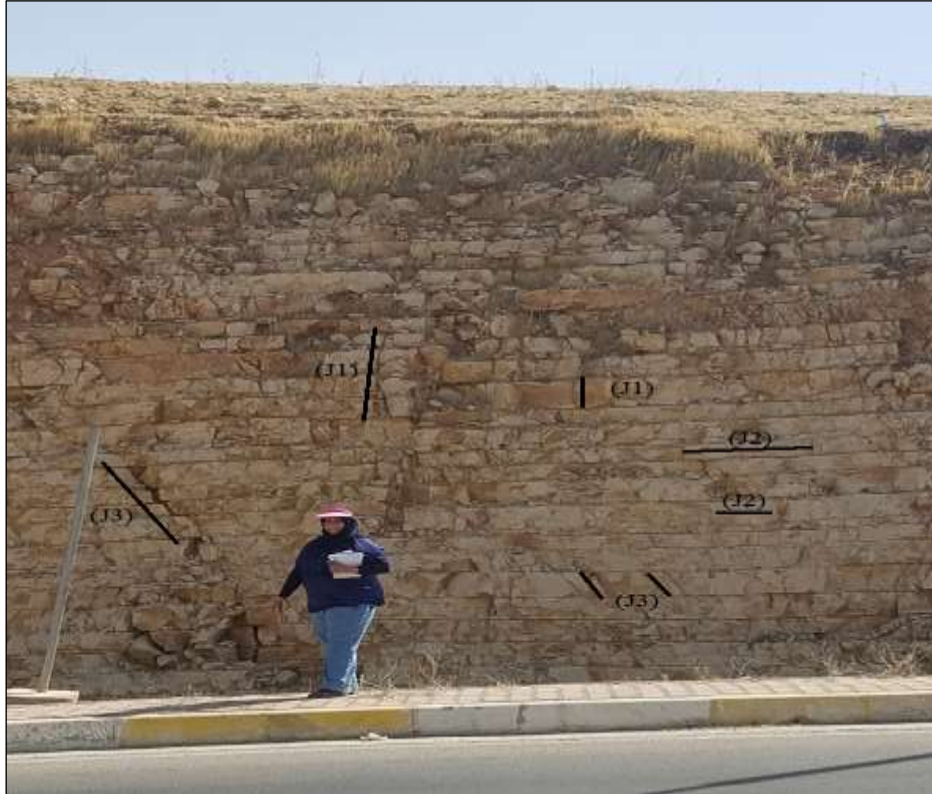
This slope is located at the axis of the NW plunge of Surdash anticline and the rock mass of the slope of this station was intersected by three discontinuities (Joint set No.1 (J1) , Joint set No.2 (J2) Joint set No.3 (J3)) and a bedding plane, as in plate 6.

Small rock-falls may occur in the upper parts due to the slope steepness.

**Plate 6** - Frontal view showing the slope of station No.6 with Joint sets No.1(J1), No.2(J2) ,Joint set No.3(J3) and bedding planes (So) . Photo direction is SW.

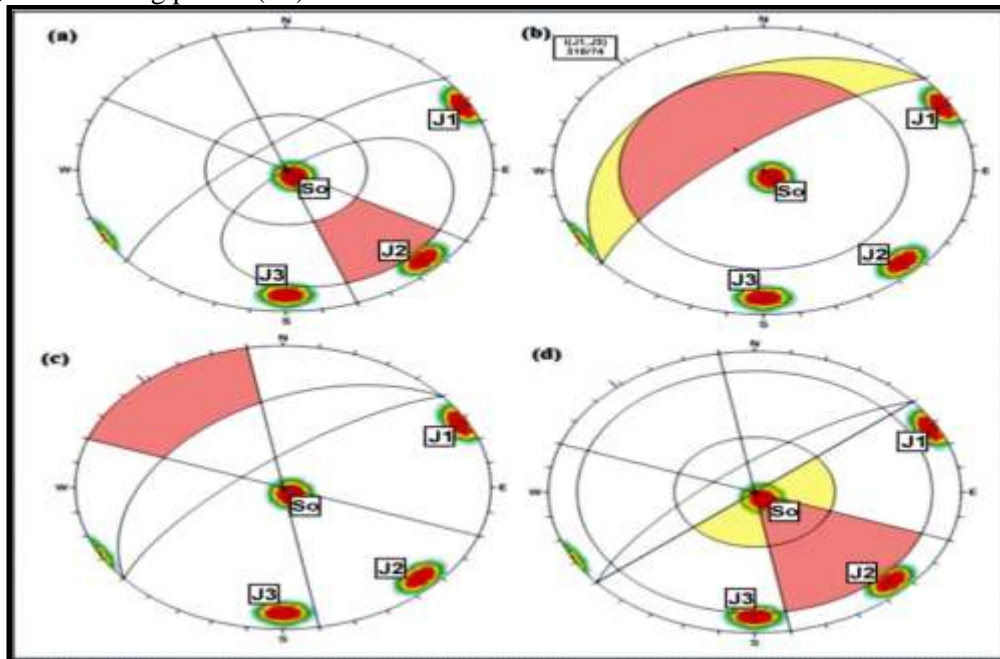
The planar sliding is not occurring because the poles of the bedding plane (So) are out of the defined area (critical zone) for the plane sliding, as in Figure-7a.

Wedge sliding may occur in the upper parts of the slope, in the plunge direction of line intersection of discontinuities the J1 and J2 (318°), as shown in Figure-7b. It can be estimated that the size of the potential blocks from the wedge sliding will be small because of the low spacing of joint sets and the small thickness of the beds.

No flexural toppling was observed due to the nonexistence of any discontinuity poles in the area shaded with pink color defined for the critical zone for flexural toppling (Figure-7c).

The direct toppling is not occurring, in spite of the presence of basal plane (So), because there is no pole of intersection to release the blocks (Figure-7d) and there are no suitable dimensions that are required for direct toppling to occur.

**Figure 7**- Kinematic analysis for station No.6:(a) plane sliding,(b)wedge sliding,(c)flexural toppling and (d) direct toppling .WhereJ1 is joint set No.1, J2 is joint set no.2,slope face is (S),bedding plane is (So) and the line of the intersection of the discontinuities is (I).

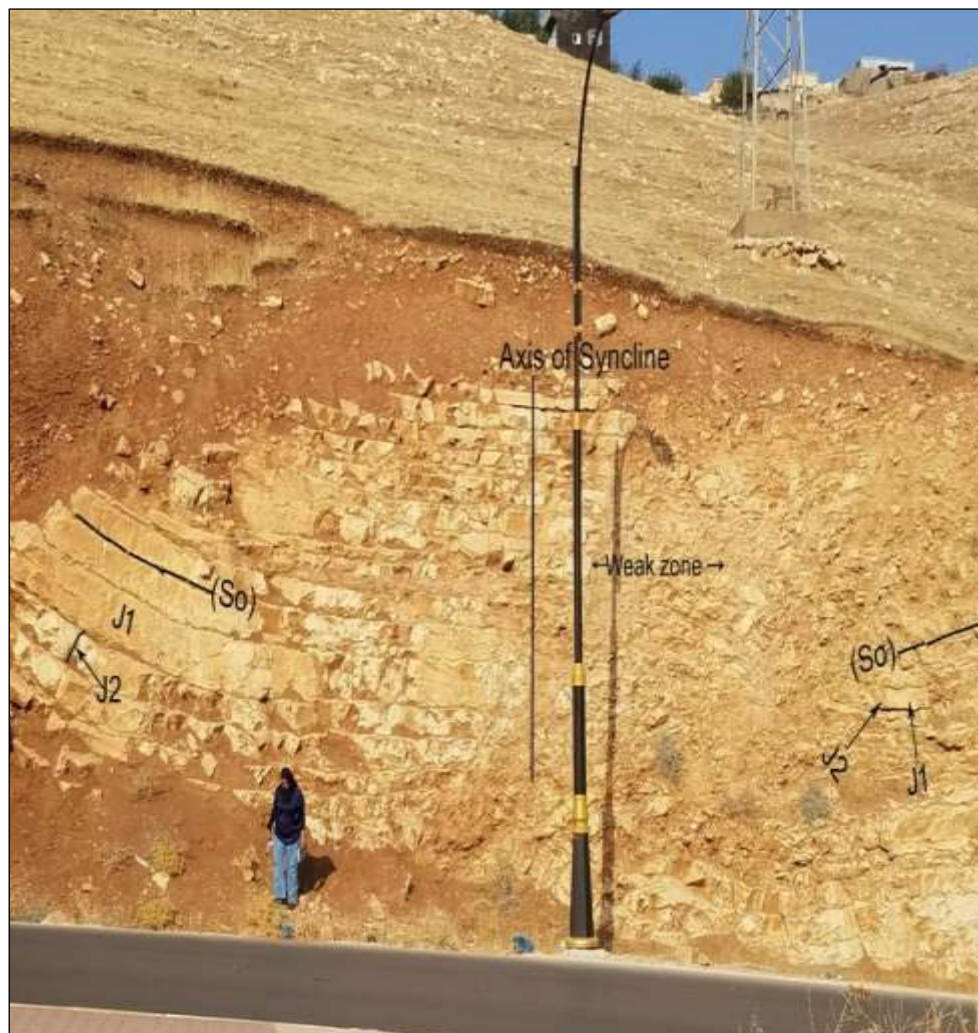
This slope is a minor fold (Syncline ). Both syncline limbs are intersected with tow joint sets in addition to the bedding plane which is considered as a discontinuity, as shown in plate 7 and Figure -8 . No poles of any discontinuities are located in the potential area of plane sliding , so the planar sliding is not occurring, as shown in Figure-8a. Wedge sliding occurred on the bedding planes (So) of both limbs of small incongruous syncline in the direction of  $210^{\circ}$  (Figure-8b). The possibility of flexural toppling is existing about J1 in the left limb, as in Figure-8c, but it does not occur because of the persistence of J1 with a depth which defines block height as very small, so it does not promote flexural toppling. The possibility of direct toppling (Figure-8d) is due to the presence of the basal plane (So) and the pole of intersection line (I (J1, J2)), but in reality it does not occur because the basal plane (So) of the right limb and the critical intersection (I (J1, J2)) are for joints in the left limb. In spite that the kinematic analysis revealed the presence of the wedge sliding, but the slope is stable at the present time .

**Plate 7-** Frontal view showing the slope of station No.7 with Joint sets No.1(J1), No.2(J2) of each limb of the syncline and bedding plane (So) .Photo direction is NE.

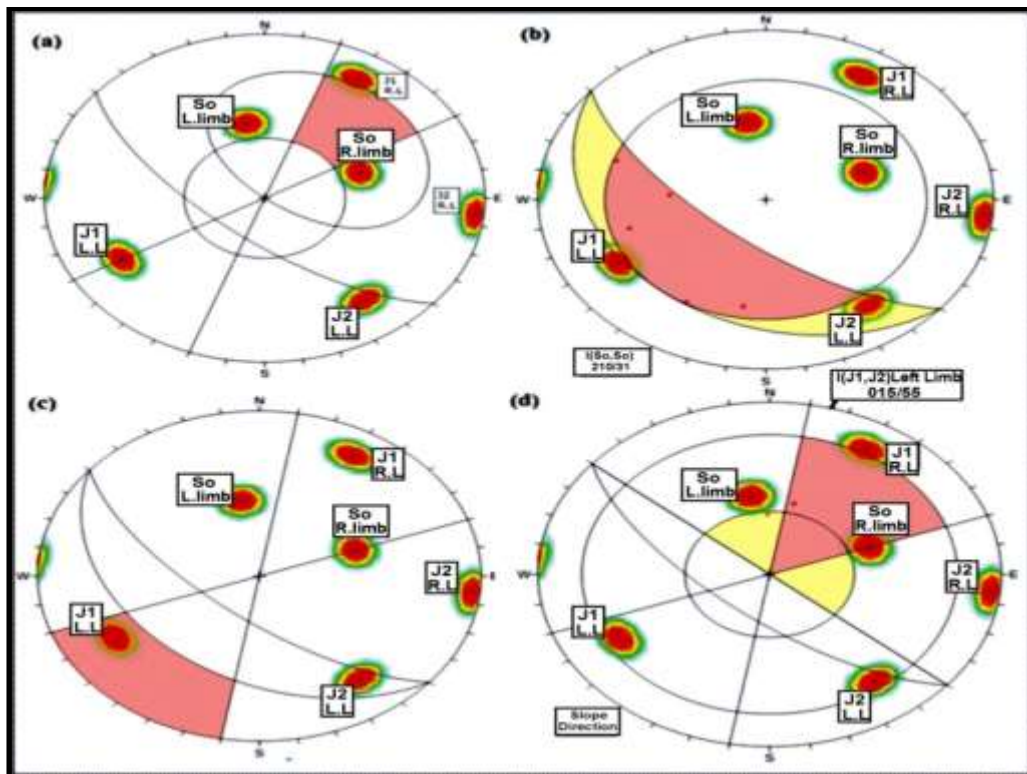
**Figure 8-** Kinematic analysis for station No.7:(a) plane sliding,(b)wedge sliding,(c)flexural toppling and (d) direct toppling .WhereJ1 is joint set No.1, J2 is joint set no.2,slope face is (S),bedding plane is (So) and the line of the intersection of the discontinuities is (I).

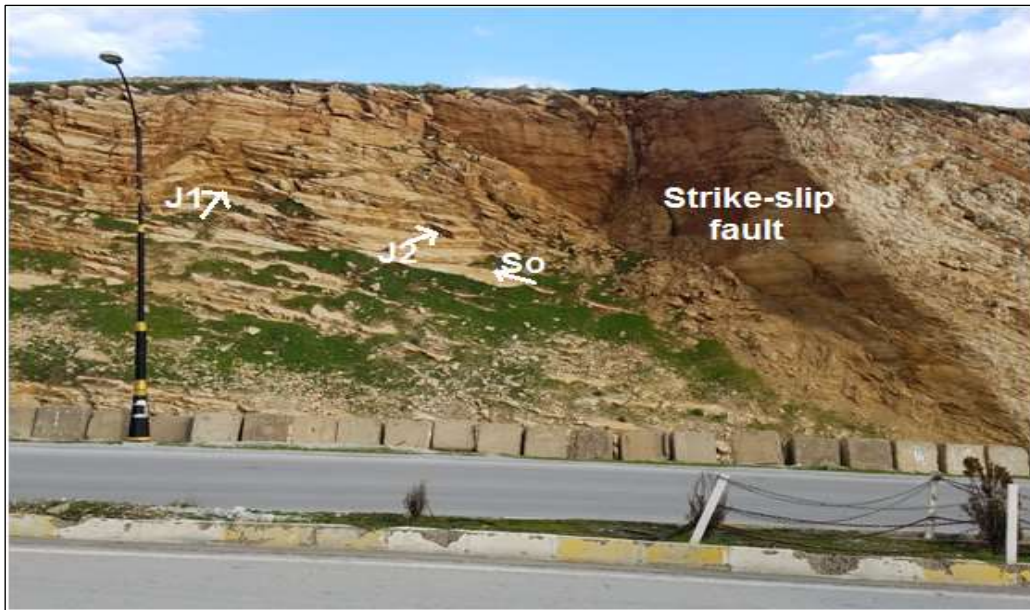
The slope of this station is intersected by 3 discontinuities, namely Strike – slip fault , Joint set No.1(J1) , and Joint set No2.(J2), in addition to the bedding plane (So) ,(Plate 8).

**Plate 8-** Frontal view showing the slope of station No.13 with Joint sets No.1(J1), No.2(J2) of each limb of the syncline and bedding plane (So) .Photo direction is NE

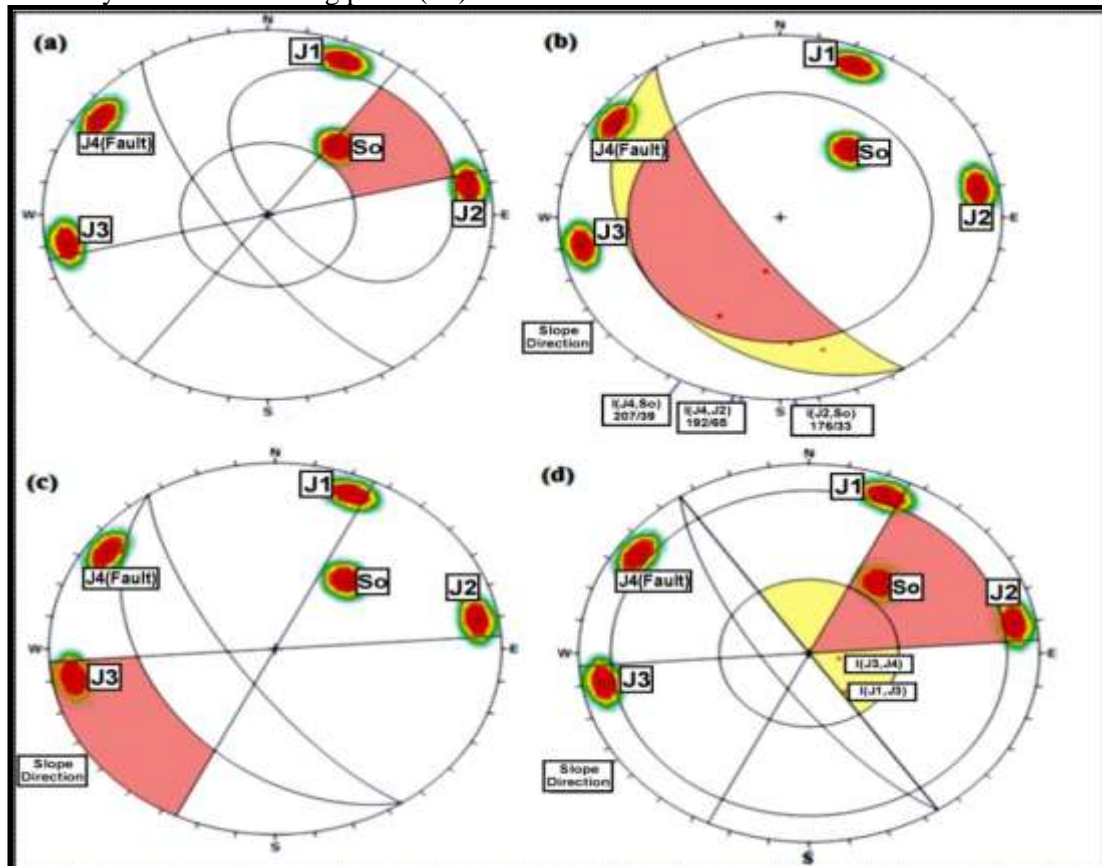
From the results of kinematic analysis (Figure-9a), a planar sliding occurred along the bedding plane (So), which plays a role as a sliding surface plane (Basal release surfaces) . The strike –slip fault J2 will act as lateral release surfaces , while J1 will act as back release surfaces.

In spite of the presence of many poles of intersection lines between joint sets in the critical zone of the wedge sliding (Figure-9b), there is a low possibility of wedge sliding only along the intersection line of J2 and J4 (Fault plane (I(J4,J2)) in the direction of  $192^\circ$ .

There is a possibility of flexural toppling J3, as shown in Figure-9c, but it is not happening because of the persistence of J1 with depth which defines the block height as very small , so it does not promote flexural toppling .

In spite of the presence of the basal plane (So) in the critical zone of the direct toppling (Figure-9d), it does not occur due to the absence of critical intersection ( Purple area) .

**Figure 9-** Kinematic analysis for station No.8:(a) plane sliding,(b)wedge sliding,(c)flexural toppling and (d) direct toppling .Where J1 is joint set No.1, J2 is joint set no.2,J3 is joint set no.3,slope face is (S),bedding plane is (So) and the line of the intersection of the discontinuities is (I)

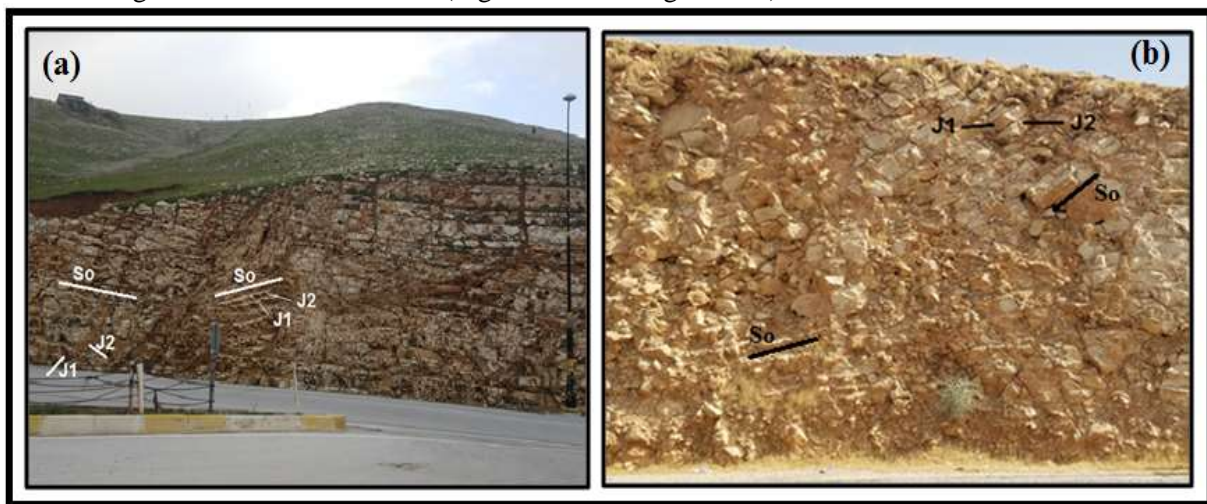
This slope consists of left and right sides. The rock mass of the left side consists of a minor fold (Syncline). Both blimbs of the syncline were intersected by two discontinuities (Joint set No.1(J1) and Joint set No.2(J2)) besides the bedding plane (So) (Plate 9a and Figure-10).

**Plate 9-** (a) Frontal view showing the slope of left side of station No.9 with Joint sets No.1 (J1) and No.2 (J2) of each limb of the syncline and bedding plane (So). Photo direction is NE. (b) Frontal view showing the slope of right side of station No.9 with Joint sets No.1 (J1), No.2(J2) and bedding plane (So). Photo direction is NE.

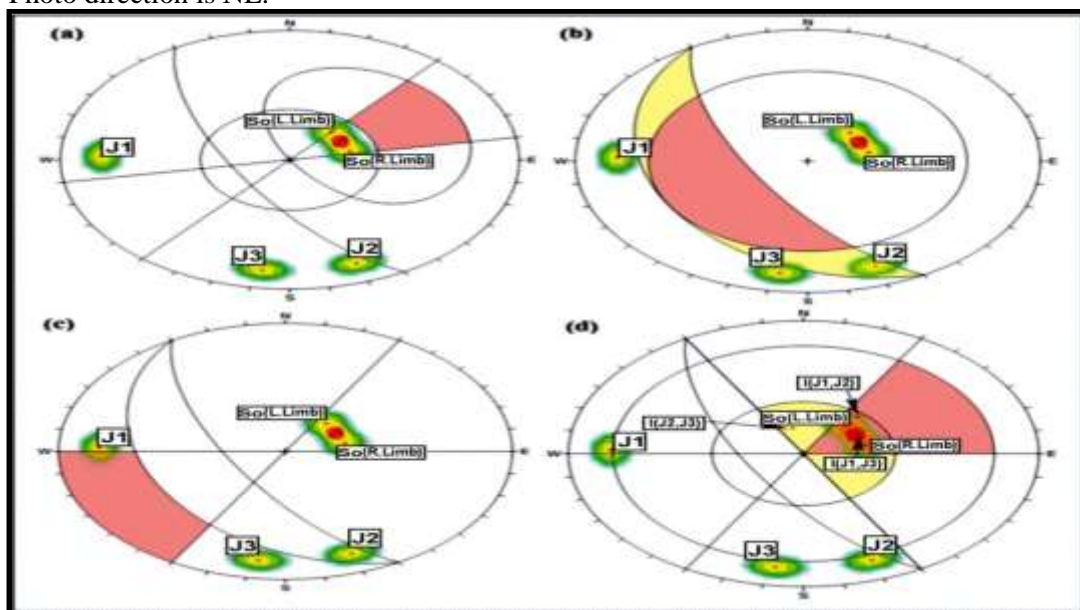
In the left side there is no planar sliding because the poles of the bedding plane (So) are out of the critical area of planar sliding. Also, there is no wedge sliding (Figure-10a and 10b) for the same reason. Flexural toppling is not occurring because there are no poles of line of intersections of any two discontinuities, in addition to the absence of basal plane ( bedding plane) in the critical area of planar sliding (Figure-10c) . Figure-10d shows the possibility of direct and oblique toppling, but in reality it does not occur because the persistence of J1 , J2 & J3 has a depth (height of blocks, perpendicular to bedding plane) which is very small for these types of failure to occur. Thus, this slope is stable at the present time in spite of the presence of a minor fold.

**Figure 10-** The kinematic analysis of left side of station No.9 shows the possibility of failure types, (a) planar sliding, (b) wedge sliding, (c) flexural toppling, (d) direct toppling.

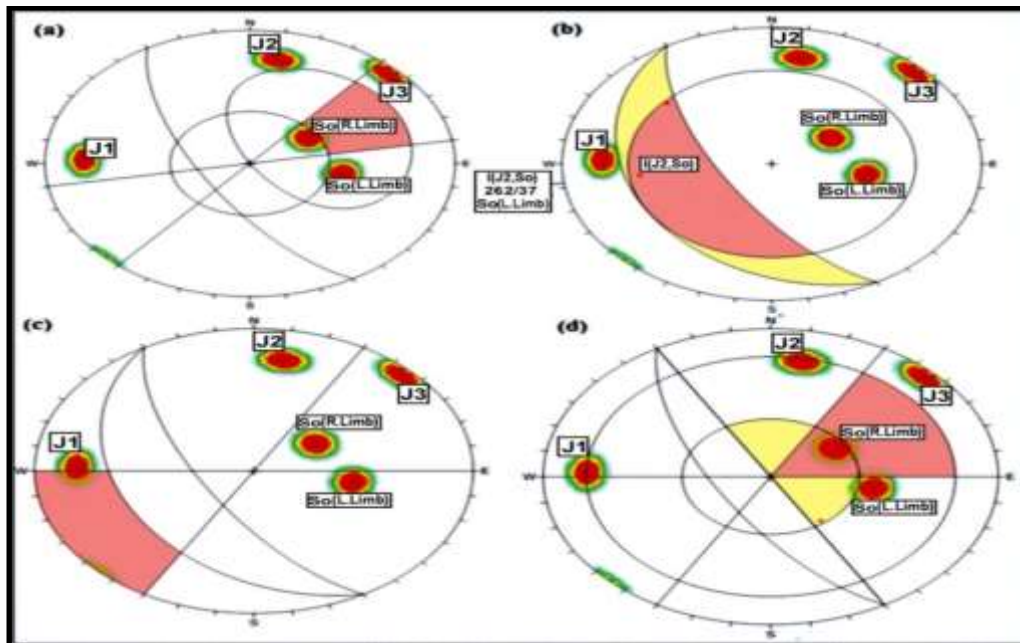
In the right side of the slope, there is a minor fold (An anticline). The rock mass of the right side of the slope of station No.9 was cut by 2 discontinuities (Joint set No.1 (J1) and Joint set No.2 (J2)) for each limb of the anticline, as shown in plate 9b and Figure-11. From kinematic analysis, it can be concluded that there is no planar sliding on the bedding plane (So), as shown in Figure-11a, because the poles of the bedding planes of the anticline are out of the critical area of the planar sliding. The wedge sliding occurs in the direction of the plunge of I (So , J2) but not along the direction of the plunge of I (So , J3) as in Figure-11b. There is no flexural toppling or direct toppling because the conditioning factors are not available (Figure-11c and Figure-11d).

**Figure 11-** The kinematic analysis of right side of station (9) , shows the possibility of failure types ,(a)planar sliding ,(b) wedge sliding ,(c) flexural toppling ,(d)direct toppling.
