# Engineering Geological Assessment for Rock Slope Stability of Chosen Areas from SW of Haibat Sultan Mountain, Kalkasmak-Koisanjaq Road / Iraq

## Thair Thamer Al-Samarrai\*

#### Abstract

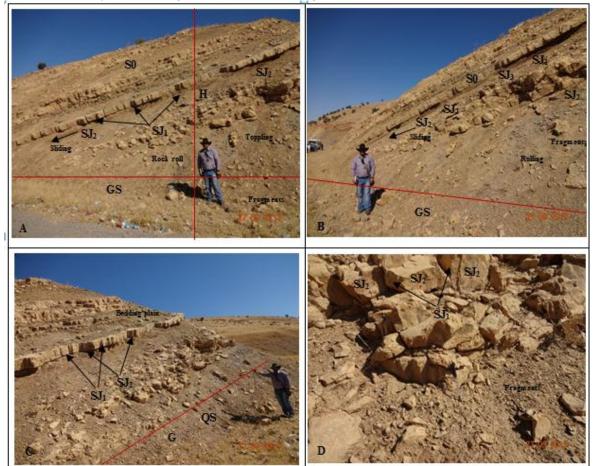
The station lies on the SW part of Haibet Sultan mountain within Pila Spi Formation, along the Kalksmaq - Koisanjaq road Figure-1. The length of the slope is about 20m, and (6m) average of height, its oriented (265/62) and the average dip of beds (194/25) Figures-2,3. The exposed rocks in slope face are light creamy to yellowish brown, fine grained, thinly to medium bedded, containing some facility (lamination 1-5cm) very closely to moderately widely spaced joints, slightly to moderately weathered, LIMESTONE, very strong with average  $\delta c=192$  MPa, and slightly to highly permeability, Figure-2. The rock mass is cut by two main sets of sub-vertical joints, in addition to the bedding plane Figures-2,3.The first set [sj1(bc)], is with an average dip (080/88), with length range, between (0.1-8.6)m, open with range between (2-30)mm, empty to filling with limestone sediments, very closely to moderately widely spaced joint. (0.05-0.58)m. Figures-2,3.The second set.sj2(ac), it average dip is (338/86), with length average between (0.3-0.7)m, open with ranges between (2-25)mm, filling with limestone sediments, very closely to moderately widely spaced joints. (0.04-0.06)m. There are some of facility and disintegration in rock mass Figure-2.

**Figure 2-** Slope of station No.1 at SW of Haibat Sultan Mountain. Kalksmaq - Koisanjaq road. A- General front view showing the high and inclination of slope, bedding plane, SJ1, SJ2, toppling and rock roll, and some of separated rock fragments. B- Side view of the slope showing the SJ1, SJ2, so trapping, rock roll, and probably of sliding and separated fragments. C-Side view of slope showing the SJ1, SJ2, toppling and rock roll, and some separated rock fragments. D- Close views showing SJ1, SJ2, fractures, disintegration in rock mass.

The main mode failures that occurred in the rock mass in this station are rock roll, toppling, and disintegration of rock fragments in which bedding plane acts as basal surfaces (B.S), SJ1, acts as back release surface (B.R.S), and SJ2 acts as lateral release surface (L.R.S). Figure-2,3. The probable types of failures in future in this station are sliding, toppling, and rock roll. In sliding, the daylighting slope at this station is favorable geometrically for plane sliding Figure-2a, b, c, the bedding acts as sliding surface while SJ1 act as (B.R.S) and SJ2 acts as (L.R.S).

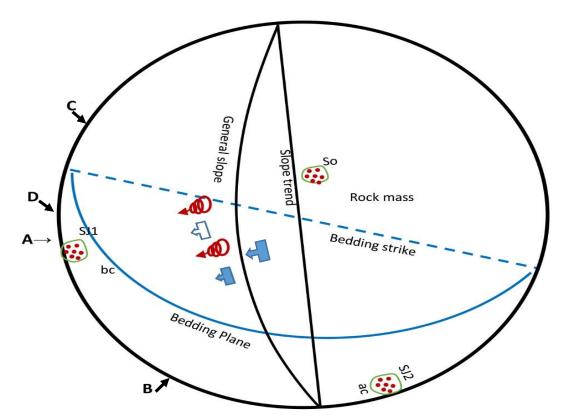
**Figure 3-** Showing the relationships among slope, bedding planes, discontinuities, and models of occur and probable failure at station No.1 in SW of Haibt Sultan mountain Kalkasmag-Koysinjaq.

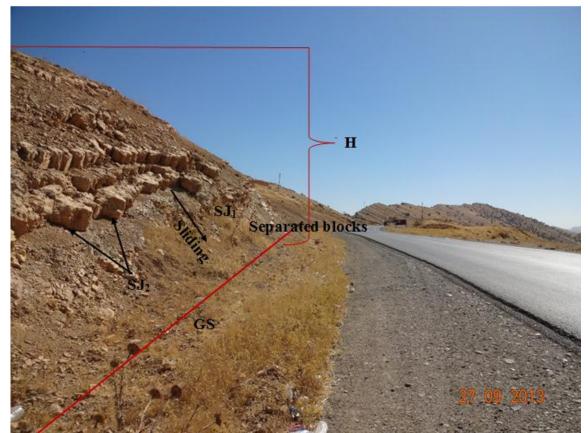
The length of the slope is about (15) m, and (6)m average of height, its oriented (256/60), average dip of bed is (205/28), Figure-4, 5.

The exposed rocks in slope face are light creamy to yellowish brown, fine graind, thinly to medium bedded, very closely to moderately widely spaced joints, slightly to moderately weathered, limestone, very strong with average  $\delta c=192$  MPa, and slightly to highly permeable, Figure-4.

The rock mass is cut by two main sets of sub-vertical joints, in addition to the bedding plane, Figure-2,3. The first set is SJ1(bc), its average dip (065,84), with length ranges between (0.1-0.6)m, open with ranges between (2-30)m, empty to fill with limestone sediments, very closely to moderately widely spaced joint,(0.07-0.6)m. The second set is SJ2(ac), its average dip (318/88), with length average between (0.4-0.8) m, open with ranges between 3-27 mm, filling with limestone sediments, very close to moderate wide joints (0.05-0.7)m. This station is very hazardous (danger) because the Conditions of sliding are available, Figure-4. Where the daylighting slope at this station is favorable geometrically for plane sliding. During the sliding the bedding planes act as sliding surfaces, while SJ1 acts (B.R.S) and SJ2 acts as (L.R.S), also the rock roll is probable to occur in this slope of the station Figure-4,5.

Figure 4- Side view of the slope in station No.2 in Kalkasmag-Koysinjaq road shows height of slope SJ1, SJ2, bedding plane, and separated blocks.

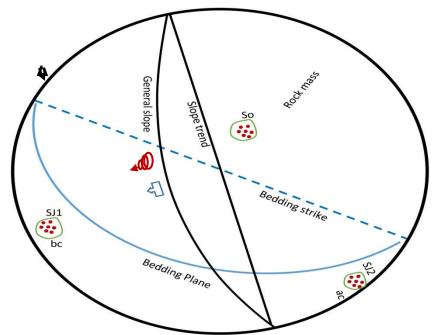
Figure 5- Shows the relationship among slope, bedding planes, discontinuities, and models of occur and probable failurs at station No.2 in SW Haibt Sultan mountain Kalkasmag-Koysinjaq.
