## Structural and Rock Slope Stability Assessment of Some Sites Along Sirwan Road, Sulaimaniyah Governorate, Northeast Iraq

Omar Ghani Aziz<sup>1\*</sup>, Thair Thamer Al-Samarrai<sup>1</sup>, Salim Hassan Al-Hakari<sup>2</sup>

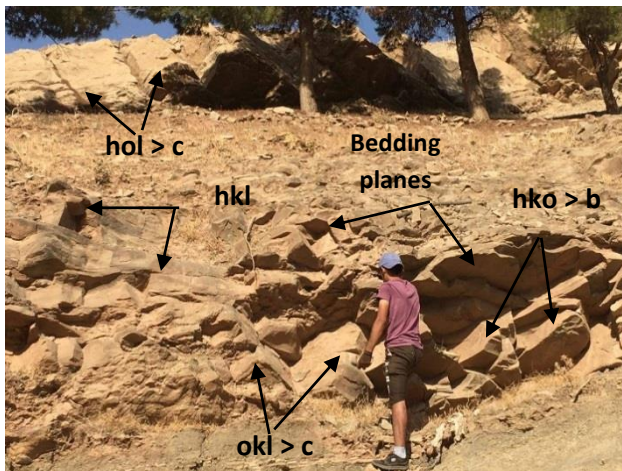
Plate 1-Joints and bedding planes in station 1

The exposed rocks composed of green, gray, and reddish brown, fine to very fine grained, laminated to very thickly bedded (1 cm – 2.5 m), very closely to widely spaced joints (2 cm – 2 m), moderately weathered, slightly to highly permeable, and extremely strong ( $\sigma_c = 242.2$  MPa), MARLY LIMESTONE.

The rocks are cut with four sets of joints ( $hko > b$ ,  $hkl$ ,  $hol > c$ , and  $okl > c$ ) as shown in plate 1, the ( $hko > b$ ) set has an average dip ( $346/53^{\circ}$ ), spacing range (2 cm – 1.5 m), and the persistence range (10 cm – 2 m), the ( $hkl$ ) set of joints has an average dip of ( $110/62^{\circ}$ ), spacing range (30 cm – 2 m) and persistence range (5 cm – 3 m), the average attitude of joints in ( $hol > c$ ) set is ( $140/86^{\circ}$ ) with spacing range (5 cm – 20 cm) and the range of persistence (7 cm – 50 cm), while the average attitude of ( $okl > c$ ) set is ( $062/60^{\circ}$ ), range of spacing between joints (10 cm – 40 cm) and range persistence (10 cm – 1 m).

The failure of rocks occurs by rock fall and toppling, due to the presence of ( $hko > b$  and  $hkl$ ) sets which act as back to lateral release surfaces, with ( $hol > c$ ) set which behaves as lateral release surface,

and the work of the (okl > c) set as back release surface, and also that rock fall is likely to occur in the future due to the same reason

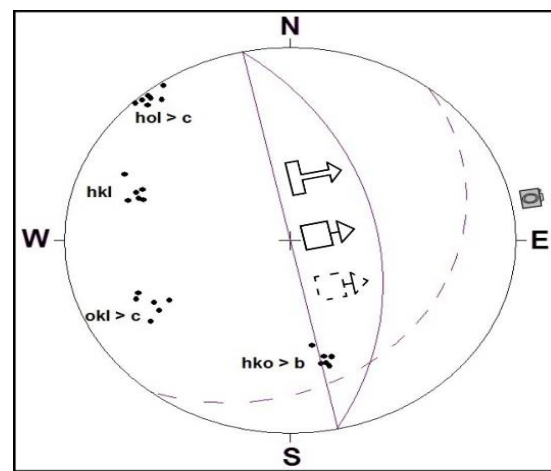
Figure 2-Stereogram shows relationship between discontinuities, slope and types of occurred and probable failures for station 1

a- Station 1: This station is located at latitude ( $35^{\circ} 06' 08''$  N) and longitude ( $45^{\circ} 42' 02''$  E), within Fatha Fn., the slope at this station is (30 m) high, its length with its trend is (107 m), and its inclination is ( $078/58^{\circ}$ ), the average bedding plane attitude is ( $128/30^{\circ}$ ), as shown in (Figure-2), so that the slope is an oblique lateral ( $d= 30^{\circ}$ ), left lateral, and discordant.

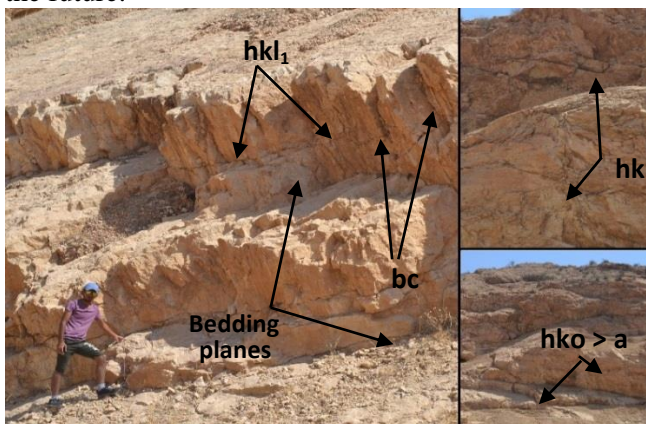
Plate 2-Joints and bedding planes in station 2

The exposed rocks composed of white, light grey, and light brown, very fine grained, very thinly to thickly bedded (5 cm – 1.95 m), closely spaced to widely spaced joints (10 cm – 1 m), moderately to highly weathered, slightly to highly permeable, and very strong ( $\sigma_c = 145.68$  MPa), LIMESTONE, as in (Plate 2).

The rocks are cut with four sets of joints (bc, hkl<sub>1</sub>, hkl<sub>2</sub>, and hko > a) of various structural orientations, average attitude of (bc) set is (059/50°), average spaces between joints of (20 cm – 80 cm) and their lengths average (30 cm – 6 m), whereas in (hkl<sub>1</sub>) set, the average dip is (162/80°), the joints have spacing range (20 cm – 1 m), and persistence range (30 cm – 2 m), (hkl<sub>2</sub>) set, in turn, has joints with an average attitude (127/22°), spacing range (13 cm – 20 cm), and persistence range (2 m – 6 m), and the joints in (hko > a) dip at an average attitude (342/81°), with spacing range (10 cm – 1 m), and persistence range (20 cm – 80 cm).

Three main rock failures' types have occurred and are likely to take place in the future; rock fall and toppling occurred due to the behave of (bc) set as back release surface, and (hkl<sub>1</sub>) set with (hko > a) set as lateral release surfaces, sliding was also happened, like the joints in (hkl<sub>2</sub>) set to act as basal surfaces, the same reason leads to the expectation that the same types of failure are likely to occur in the future.

- Removal of the unstable blocks which are liable to fail in the critical cases, as in stations 2 and 6.
- casing the slopes with covenant materials such as concrete (as in site 4) and gabions (as in sites 2 and 6), construction of retaining walls and digging of protective trenches to protect the slopes and reduce the hazard, as in stations 1, 3, and 5, as well as using warning signs along hazardous locations that are prone to collapse to attract the attention of pedestrians to the riskiness of the place.

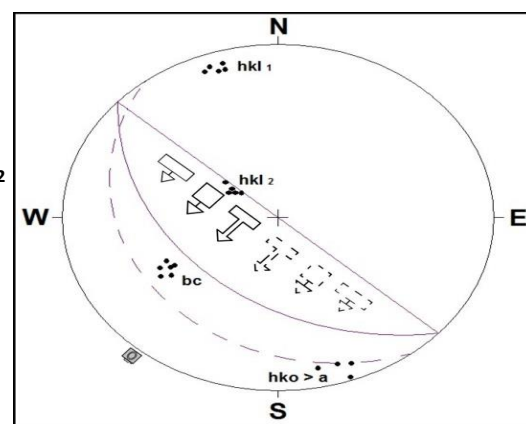
Figure 3-Stereogram shows relationship between discontinuities, slope and types of occurred and probable failures for station 2

Station 2: It lies about (360 m) to the northwest of station 1, and is located at latitude (35° 06' 20" N) and longitude (45° 42' 59" E), within Pila Spi Fn., the slope at this station is (64 m) high, the length is about (130 m) with its trend, its inclination is (222/52°), and the beds dip at an average attitude (232/30°), as in (Figure-3), so that the slope is a parallel (d= 2°), right lateral, and concordant.

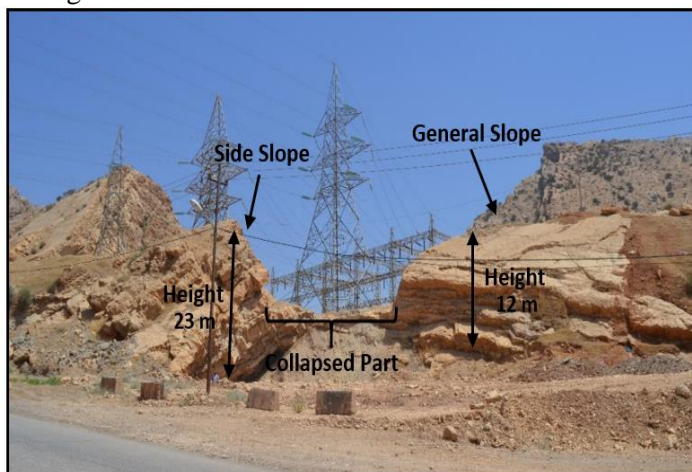
**Plate 3**-Joints and bedding plane in station 3

The exposed rocks composed of light grey and brown, very fine grained, thinly to thickly bedded (10 cm – 1.14 m), extremely closely to very widely spaced joints (1 cm – 2.5 m), moderately to highly weathered, slightly to highly permeable, and very strong (144.88 MPa), LIMESTONE rocks, as in (Plate 3), so that, the general slope is classified as an oblique lateral slope ( $d= 62^{\circ}$ ), right lateral, and concordant.

The rocks are cut with four sets of joints of various structural directions ( $ac$ ,  $hkl$ ,  $okl > b$ , and  $okl > c$ ), the ( $ac$ ) set has average attitude ( $171/85^{\circ}$ ), spacing range (2 cm – 2.5 m), and persistence range of (8 cm – 3 m), while the joints in ( $hkl$ ) have average attitude ( $122/37^{\circ}$ ), spacing range (1 cm – 50 cm) and persistence range (25 cm – 1.2 m), average attitude of the joints in ( $okl > b$ ) set is ( $217/34^{\circ}$ ), the range of spacing (5 cm – 2 m), with persistence range (70 cm – 3 m), and the ( $okl > c$ ) set has an average attitude ( $341/80^{\circ}$ ), spacing range (1 m – 1.5 m), and persistence range between (80 cm – 2 m).

Failure occurred in the form of rock fall, due to the fact that the joints in ( $ac$ ) set act as back release surfaces, and joints in ( $okl > c$ ) set behave as lateral release surfaces.

Rock fall is expected to occur in the future due to the presence of overhanging rock mass in the side slope, as well as the behave of joint sets mentioned above, it is also likely to expect sliding as the joints in ( $okl > b$ ) set act as basal surface, and also the bedding plane situation that encourages the sliding in some rock blocks.

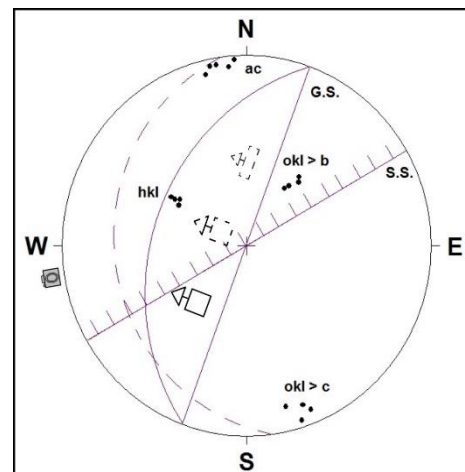
**Figure 4**-Stereogram shows relationship between discontinuities, slope and types of occurred and probable failures for station 3

b- Station 3: this station lies about (165 m) to the north of station 2, and is located at latitude ( $35^{\circ} 06' 25''$  N) and longitude ( $45^{\circ} 41' 59''$  E), within Pila Spi Fn., the slope at this station consists of 2 parts; general (first) slope which is (12 m) high, and its length with its trend is (40 m), with inclination ( $290/48^{\circ}$ ), the slope changes to the left forming side (second) slope that is (10 m) high, and its length with its trend is (23 m), with inclination ( $150/90^{\circ}$ -OH), and the bedding attitude is ( $262/29^{\circ}$ ) as in (Figure-4).

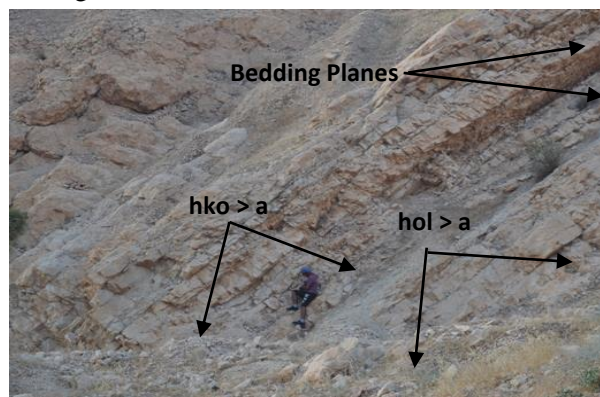
Plate 4-Discontinuities in station no. 4

The exposed rocks composed of light to dark brown, very fine grained, thinly to very thickly bedded (15 cm – 2.2 m), very closely spaced to widely spaced joints (2 cm – 2 m), moderately to highly weathered, and very highly weathered in some areas, slightly permeable to highly permeable in some areas, extremely strong ( $\sigma_c = 216$  MPa), LIMESTONE, as in (Plate 4).

The layering at this station is cut with two sets of joints ( $hko > a$ , and  $hol > a$ ); the average attitude of joints in ( $hko > a$ ) is ( $154/74^{\circ}$ ), the spacing range is (20 cm – 1.5 m), with persistence range (30 cm

– 7 m), whereas joints in ( $hol > a$ ) set have an average attitude ( $070/41^\circ$ ), spacing range between (2 cm – 2 m), and their persistence range between (10 cm – 2 m).

The rock fall was occurred in the station, as the joints in ( $hko > a$ ) set acts as lateral release surfaces, and joints in ( $hol > a$ ) set act as back release surface, the same reasons make the rock fall as probable failure in this station, also the situation of the bedding planes leads to the expectation of sliding occurrence in the future.

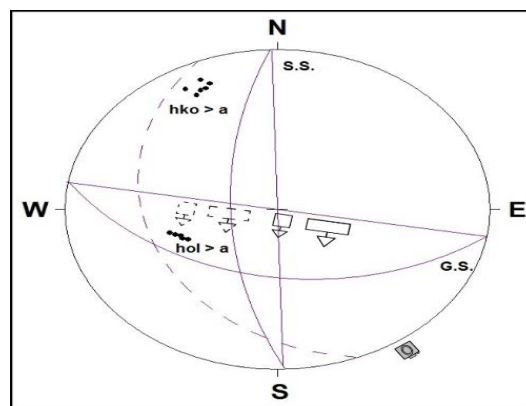
Figure 5-Stereogram shows relationship between discontinuities, slope and types of occurred and probable failures for station 4

c- Station 4: This station lies about (145 m) to the north of the previous station, and is located at latitude ( $35^{\circ} 06' 29''$  N) and longitude ( $45^{\circ} 41' 59''$  E), within Pila Spi Fn., the slope at this station consists of general (first) slope which is (88 m) high, and its length with its trend is (117 m), with inclination ( $190/55^{\circ}$ ), and side (second) slope that is (85 m) high, and its length with its trend is (80 m), with inclination ( $268/72^{\circ}$ ), and the average bedding plane attitude is ( $248/38^{\circ}$ ), as in (Figure-5), so that, the general slope is an oblique lateral ( $d= 58^{\circ}$ ), left lateral, and concordant.

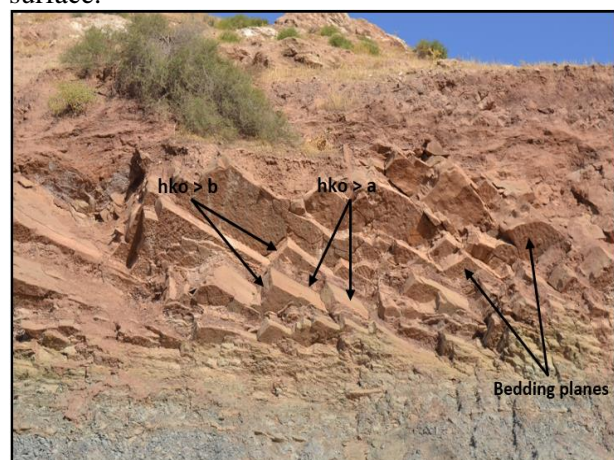
Plate 5-Joints and bedding plane in station 5

The exposed rocks composed of gray and reddish brown, fine to very fine grained, medium to thickly bedded (30 cm – 2 m), very closely spaced to widely spaced joints (3 cm – 1 m), moderately to highly weathered, slightly to highly permeable, and extremely strong (239.8 MPa), MARLY LIMESTONE, as in (Plate 5).

The rocks in this station are cut with two sets of joints ( $hko > a$ , and  $hko > b$ ); the first has an average attitude ( $056/58^\circ$ ), spacing range (3 cm – 80 cm), and persistence range (12 cm – 2 m), while the second has average attitude ( $144/53^\circ$ ), and the persistence range (10 cm – 1.2 m) with spacing range between (20 cm – 1 m).

Rock fall and toppling occurred in the station and are also likely to take place in the future as the joints in ( $hko > a$ ) set and act as back release surfaces, and ( $hko > b$ ) set behaves as lateral release surface.

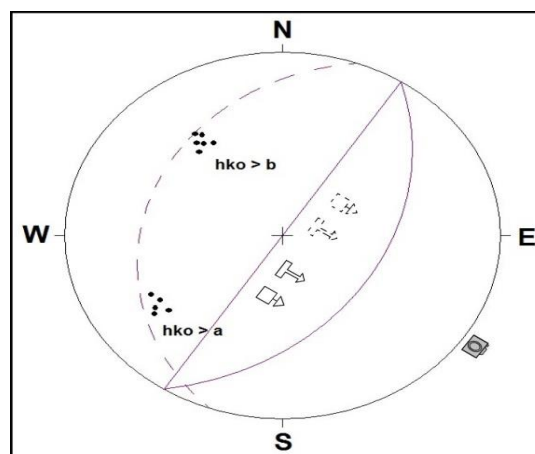
Figure 6-Stereogram shows relationship between discontinuities, slope and types of occurred and probable failures for station 5

d- Station no. 5: It lies about (300 m) to the northwest of station 4, and is located at latitude ( $35^\circ 06' 39''$  N) and longitude ( $45^\circ 41' 55''$  E), within Fatha Fn., the slope at this station is (65 m) high, and the length with its trend is (126 m), with inclination ( $123/52^\circ$ ), and bedding dips at an attitude ( $290/36^\circ$ ), as in (Figure-6), so the slope is a parallel slope ( $d= 14^\circ$ ), left lateral, and discordant

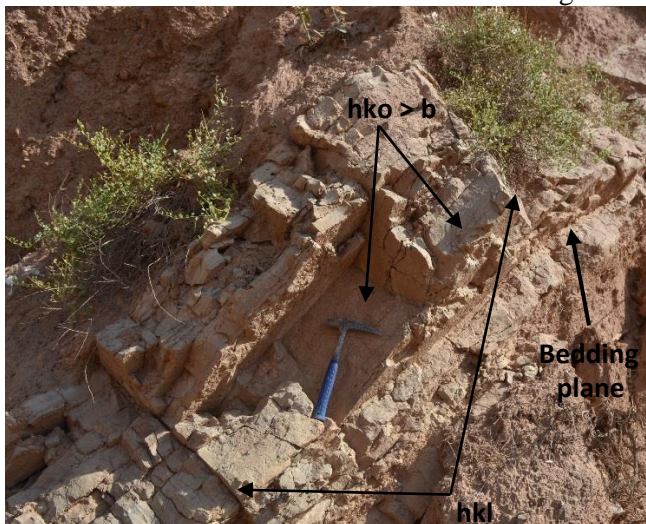
Plate 6-Joints and bedding planes in station 6

The exposed rocks composed of grey to reddish brown, fine to very fine grained with the presence of coarse sandstone in some parts, thinly to very thickly bedded (10 cm – 4.5 m), very closely spaced to very widely spaced joints (5 cm – 3 m), highly weathered to completely weathered at some parts, slightly permeable to highly permeable in some areas, strong ( $\sigma_c = 96$  MPa), MARLY LIMESTONE, as shown in (Plate 6).

The rocks are cut with two sets of joints of different structural orientations ( $hko > b$ , and  $hol > a$ ), the first has an average attitude ( $144/52^{\circ}$ ), spacing range (5 cm – 40 cm), and persistence range (20 cm – 2 m), while the second set of joints has an average attitude ( $044/50^{\circ}$ ), and the joints persistence range between (10 cm – 1 m) with spacing range between (20 cm – 3 m).

As the joints in ( $hko > b$ ) set serve as lateral release surface, and ( $hol > a$ ) set joints act as back release surfaces, rock fall took place in this station, the behaves of the joint sets, as well as, the bedding planes situation in the station makes it favorable that rock failures expected in this station to occur in the future in the form of fall and sliding.

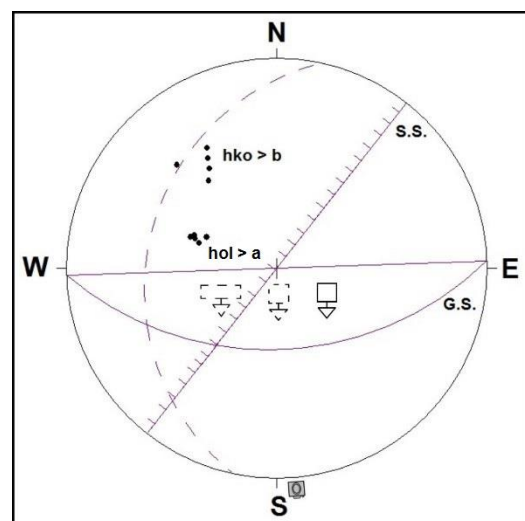
Figure 7-Stereogram shows relationship between discontinuities, slope, and types of occurred and probable failures for station 6

e- Station 6: This station lies about (275 m) to the southwest of the previous station, and is located at latitude ( $35^{\circ} 06' 31''$  N) and longitude ( $45^{\circ} 41' 50''$  E), within Fatha Fn., the slope at this station consists of general slope (first slope) which is about (20 m) high, its length with its trend is (72.7 m), and its inclination is ( $178/58^{\circ}$ ), and side slope (second slope) that is (18 m) high, its length with its trend is (22.5 m), with inclination ( $128/90^{\circ}$ -OH), and bedding plane attitude is ( $282/38^{\circ}$ ), as in (Figure-7), so that, the general slope is a orthogonal ( $d= 76^{\circ}$ ), left lateral, and discordant.
