## Assessment of Rock Slope Stability along Sulaimaniyah -Qaradagh Main Road, Near Dararash Village, Sulaimaniyah, NE-Iraq

Ghafor A. Hamasur\*, Fahmy O. Mohammad and Ashna J. Ahmed  
Department of Geology, College of Science, University of Sulaimani, Sulaimani, Iraq,

For assessing the stability of rock slopes in the area, seven stations (rock-cut slopes) were selected along the road and evaluated by kinematic analysis, using DIPS v6.008 software and slope mass rating system (SMRTool - v205 software).

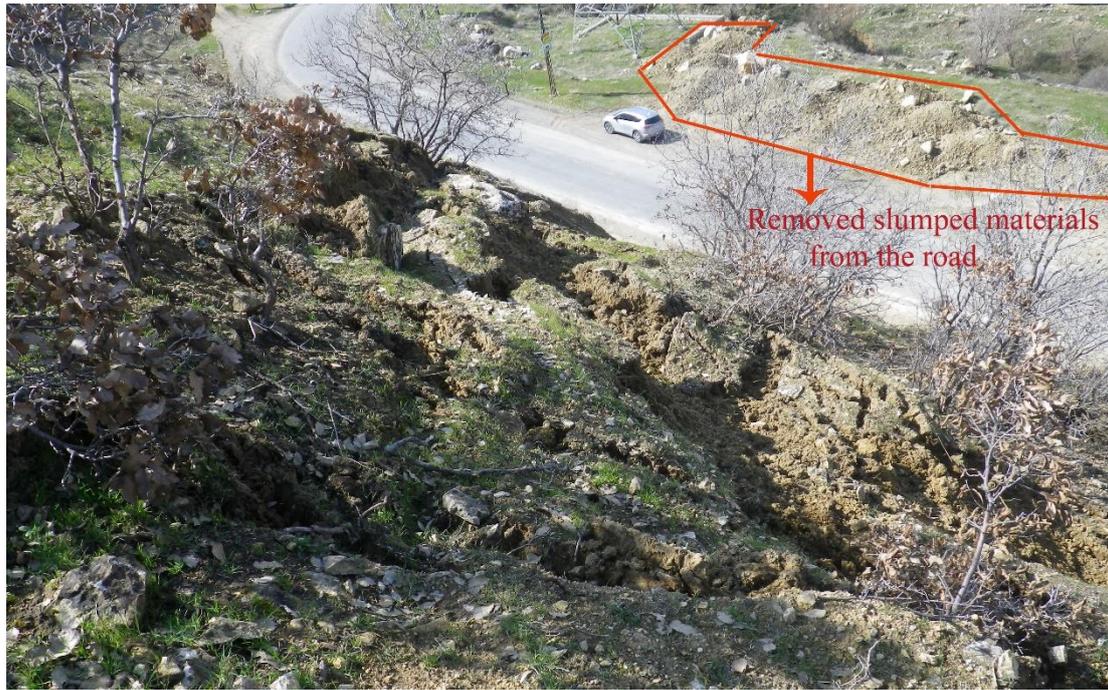
**Figure 1**-General view showing slumped materials to the left of the road and removed part that was blocked the road at station no.4

Road networks are the only way of communication in mountainous regions. The presently studied road-cut slopes along Dararash village-Qaradagh town in Sulaymaniyah city –NE Iraq failed many times at various locations and have become more liable to different types of failure. The failed materials occasionally blocked the road, as occurred in February, 2019. Figure-1 shows that the slumped materials were removed from the road at station no.4.

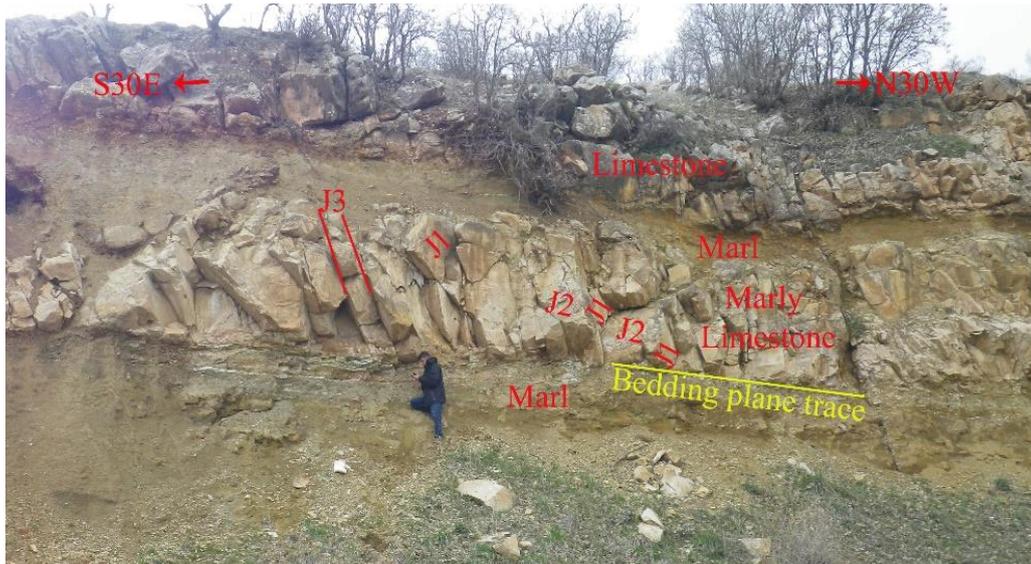
Figure 10-Field view for station no.6 with marked discontinuity sets

All rock slope stations are sites that already failed, as shown in Figures-(6, 8, 10, 12, 14, 16 & 17). The results of all kinematic analyses are listed in Table-4.

Depending on the SMR-values, stations no.2 & 6 require immediate treatment, such as removing unstable parts and constructing surface drainage and deep drainage pipes into the slopes. Stations no.1, 5 & 7 require concrete support (shotcrete, dental concrete, toe walls) and reinforcement support (bolts, anchors), while station no.3 requires protection support, such as toe ditch and toe fence.

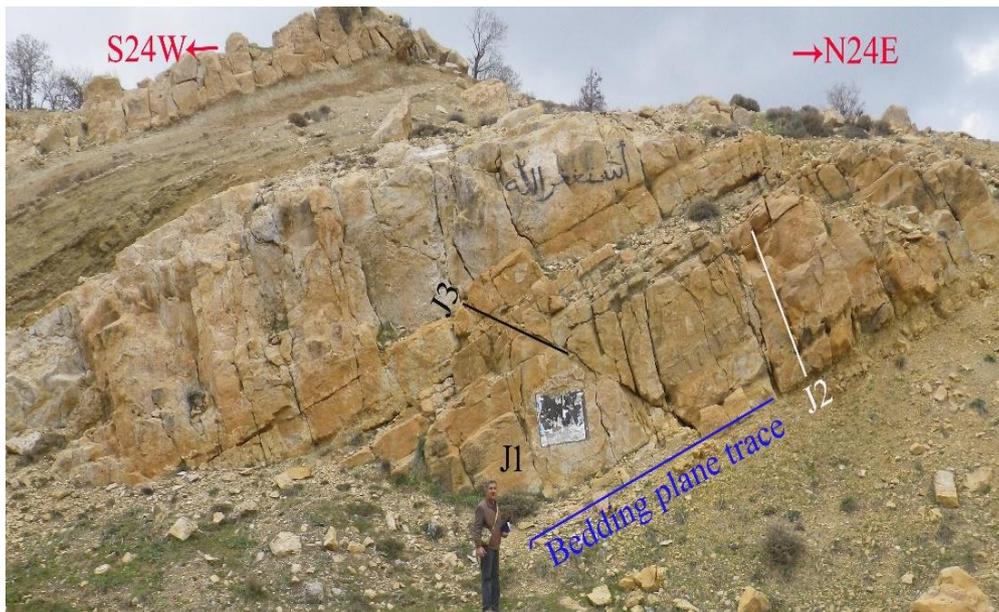
**Figure 12-**Field view for station no.7 with marked discontinuity sets

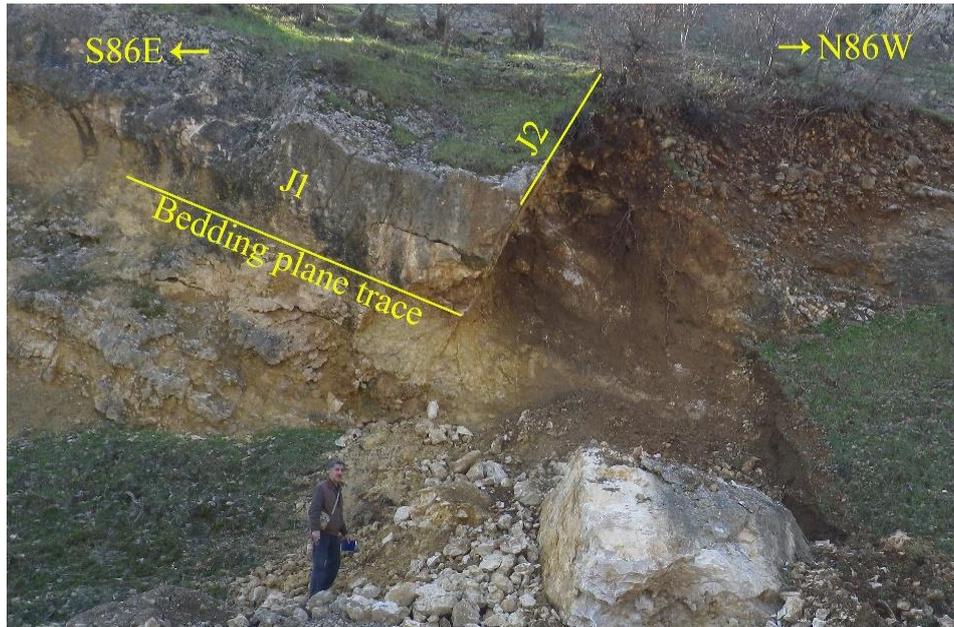
**Figure 14**-Field view for station no.1 with marked discontinuity sets

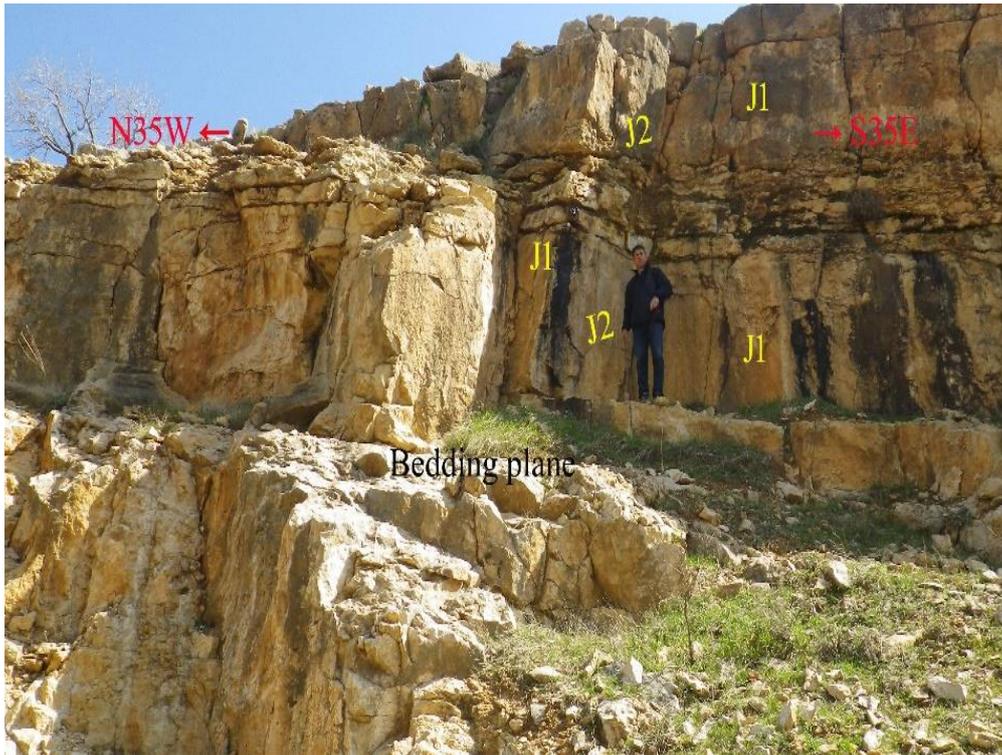
**Figure 16**-Field view for station no.3 with marked discontinuity sets

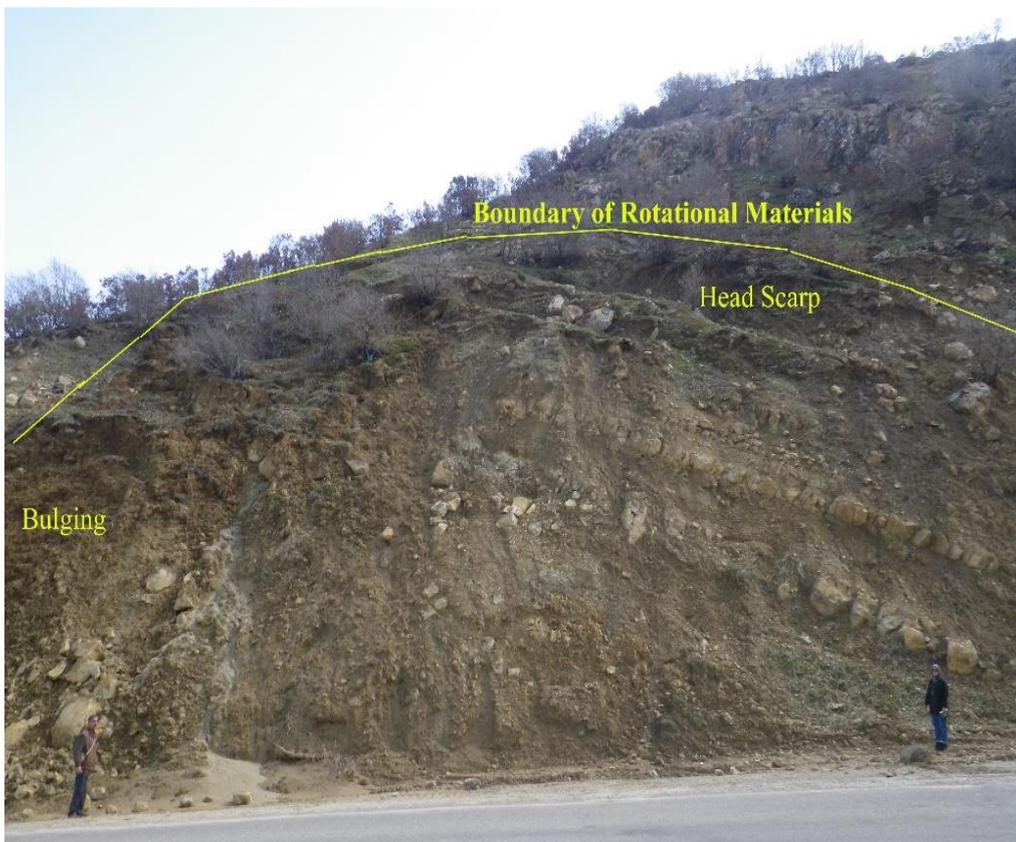
Due to the lack of structural and failure surface data (discontinuities attitude and attitude of slumping surface) in station no.4, stability analysis was interpreted by using a general conventional method. Depending on the field criterion and vision, it can be interpreted as having a rotational failure, the upper part of which consisting of slump motion and the lower part is of flow motion, as shown in Figure-17. In rotational failure, the surface of rupture is curved concavely upward (spoon shaped), and the slide movement is more or less rotational. A slump is an example of a small rotational landslide. the body of the slump may be further subdivided into discrete blocks, each bounded by smaller individual shear surfaces that dip backward into the slope. Slumps have a characteristic head scarp (which exposes the upper part of the failure surface) and a bulging toe (where material piles up) [26].

**Figure 17**-Rotational failure in station no.4, with an upper part of slump motion and lower part of flow motion
